Failures in Design and Construction and Their Investigation – Case Studies

Emilio M. Morales, MSCE, FPICE, FASEP ¹⁾

ABSTRACT: Several significant failures of Civil Engineering Projects ranging from catastrophic to functional failures have been investigated involving structures or structural components.

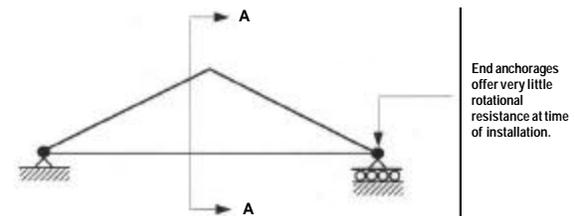
1. MODEL OF TRUSS SYSTEM

The figure below shows the unfavorable geometry represented by a triangular shaped truss. Vertically, the system would be “Stable”. However, once there is lateral disturbance, the system failed by toppling progressively.

As can be seen, this unfavorable geometry offered very little rotational resistance when the Trusses were loaded laterally. In some of the Truss ends that did not fall, the Truss ends were restrained by the bolts but toppled on its side just the same because the ends were twisted due to lack of rotational resistance.

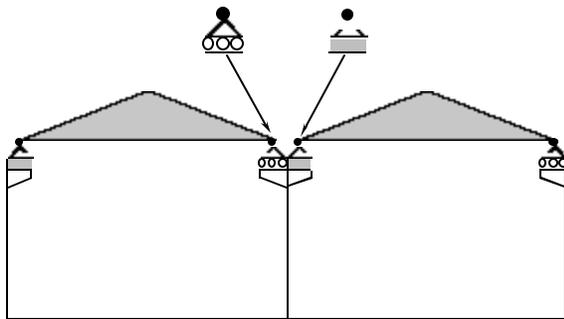
The Roof Framing System adopted consisted of two Truss Bents resting on corbels in a Roller/Pin connection detail as shown below:

Thus, the Truss Bents could not participate efficiently in carrying lateral loads and redistributing loads as these are essentially simply supported elevations. Thus, there are no redundancies in the structure nor alternative stress paths in case of overstress.

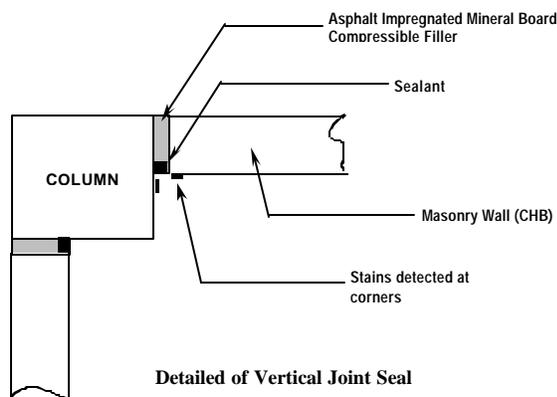
A clear study of the detail above clearly showed that the joint seal placement was **reversed!**

The Asphalt Impregnated Mineral Board Compressible Filler was exposed to the elements and the sealant was placed inside. Weathering and exposure to sunlight melted the asphalt and degraded the mineral fiber.

Breaks in the sealant allowed the melted asphalt diluted by water to find its way inside and was initially suspected as stains from bird droppings which equates to potential salmonella infection.

It required removal of these numerous vertical joints throughout the Seven Storey Facility and replacement with proper jointing procedures. This was very expensive for the owner.

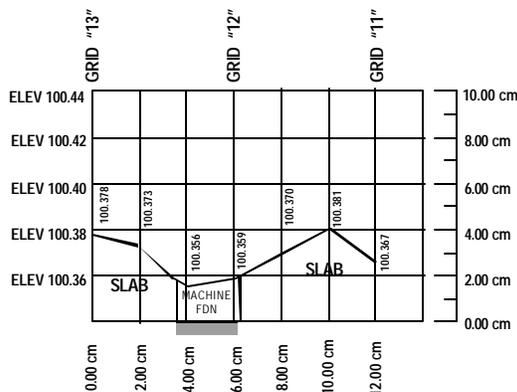
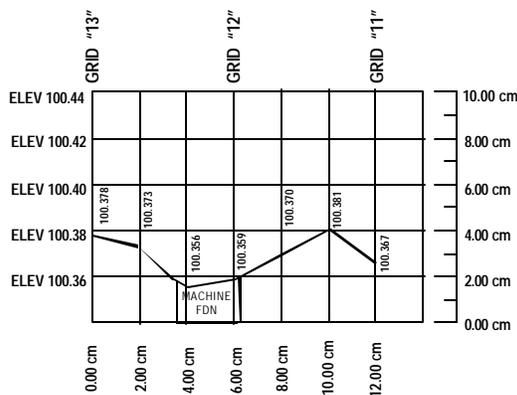
11 TRANSVERSE CROSS-SECTION (GRID R)
SCALE HOR. 1 : 200 VERT 1 : 2 MTS

The investigation results corroborated our initial findings. The Topo Survey confirmed that the slabs were indeed rising and dragging the equipment up.

A section through the longitudinal and transverse axes of the equipment revealed the vertical heaving of the slabs as well as the equipment foundation without a doubt.
