INVESTIGATION OF CRACKING OF A LARGE AREA WEAR SLAB - LESSONS LEARNED

Emilio M. Morales, MSCE

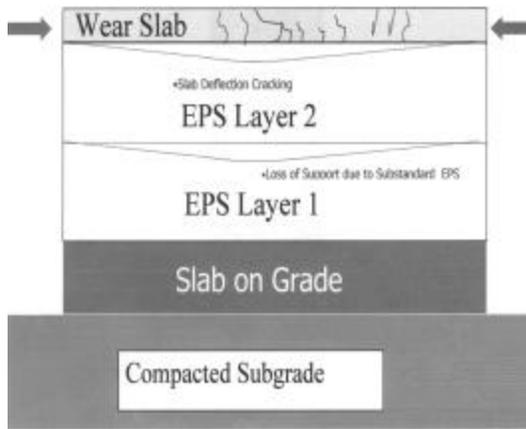
Figure 1.0

The wear slab is underlain by two layers of Expanded Polystyrene (EPS) supported in turn by a structural slab on grade. The slab on grade rests on well compacted gravel base course on compacted subgrade.

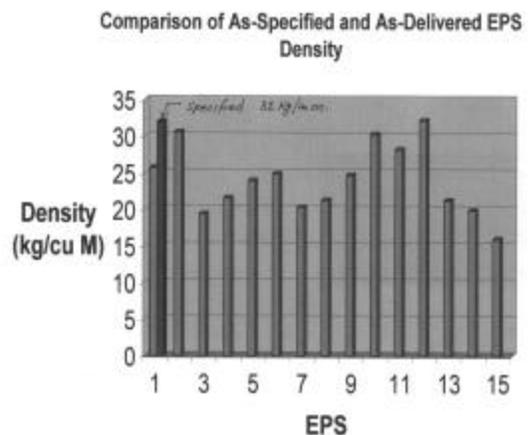
Figure 2.0

1. The concrete was grossly understrength.
2. The EPS is substandard and very much below the specified density of 32 kg/cu.m.¹ and the modulus was also low.
