## SETTLEMENT OF A LIGHT RAIL PIER SUPPORTED ON LARGE DIAMETER BORED PILES REMEDIATED BY JET GROUTING

**Emilio M. Morales MSCE**  
EM<sup>2</sup>A Partners & Co  
Quezon City, MM  
(Philippines)

**Toshio Ono**  
MMLRT Consultants  
Tokyo, Japan

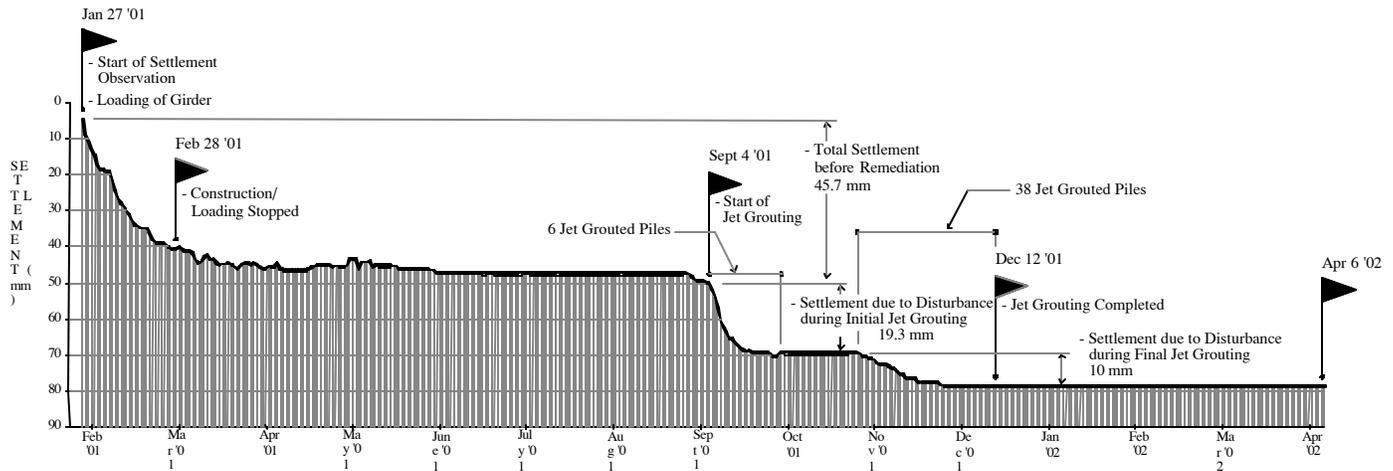
Fig. 1. Settlement History

The settlements were alarming as the pier was supported on bored piling that is supposed to be socketed at least 2000 mm into bedrock. This initial settlement of 36mm caused concern and was continuing progressively until loading and other construction activities were halted. By that time, a total of 45.7mm maximum settlement had already resulted. *Fig. 1* shows the settlement profile.

The erection subcontractor for the Precast Concrete Box Girder segments specified a maximum short-term settlement of 30mm and a total maximum long-term settlement of 45mm. Clearly, the recorded initial settlements have already actually violated these values and the Box Girders have to be raised by jacking in order to level the Girders.

Immediately upon detection of on-going settlements, formal settlement monitoring and recording was started 27 January 2001. Because of the continuing high rate of settlement, construction loading was halted on February 28, 2001. Heavy Structural Steel scaffolding was placed to support the Girders and Jacking relevelled the Girders. Still settlements continued but at a reduced rate resulting in a total of 45.7mm settlement of the Pile Cap.

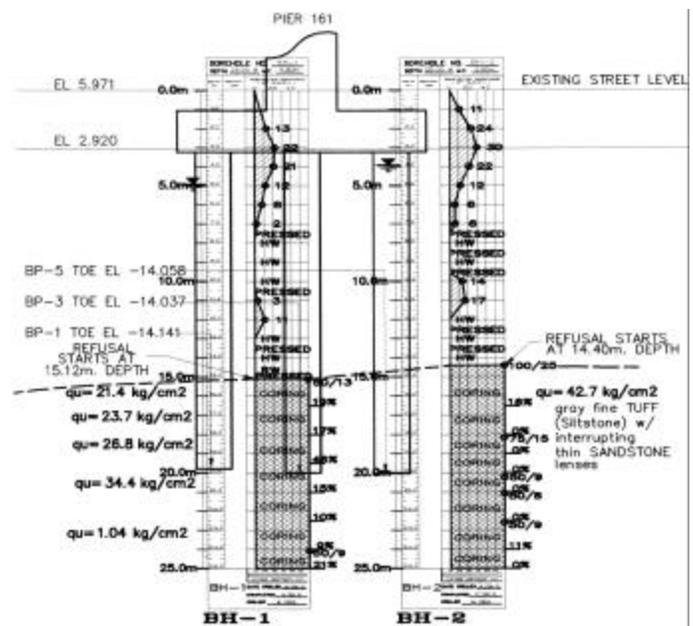
Fig. 2. Soil Profile near Pier Foundation

The check Borings (Fig. 2 below) indicated that the overburden soils are relatively poor to very poor beyond 7 meters as shown in the Soil Profile below for BH-1 and BH-2.

As can be seen, refusal was only encountered at a depth of 15.12 meters and 14.40 meters below existing Natural Ground Line.

Soil Profile taken across BH-1 and BH-2 as shown in Fig. 2 indicate the slightly sloping bedrock layer.

The ensuing check borings (*Fig. 1 and Fig. 2*) verified that the Bored Pile tips were resting on very soft soils or on highly weathered bedrock.

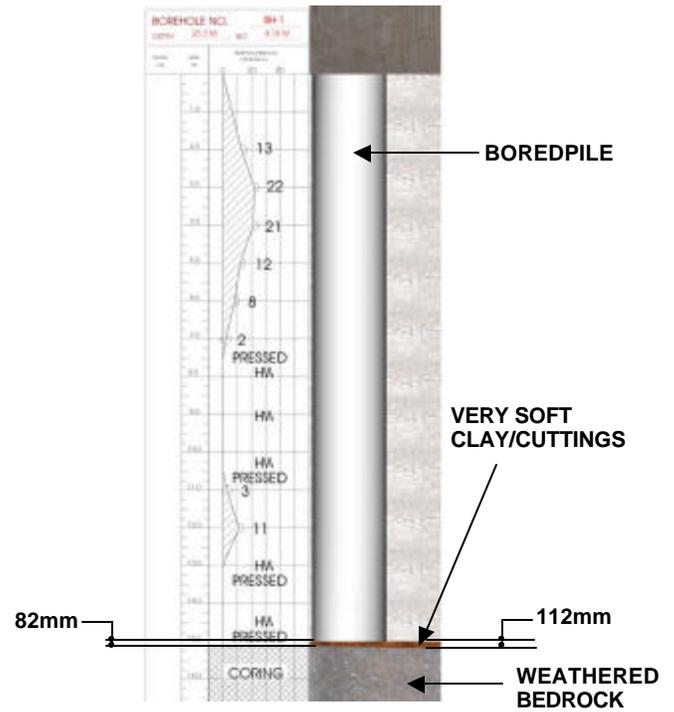
Fig. 3. Gap detected during coring at center of Bored Pile correlated with Soil Profile

It was suspected that the actual gap between some of the Bored pile tips and the bedrock are as thick as 150 mm before settlements occurred as detected from later corings done at the center of the bored piles as shown in *Fig. 3*.

Thus, the heavily loaded Bored Piles were either resting on very soft clay or on relatively weathered Bedrock very near the Soil Bedrock interface without adequate socketing.

The settlement record for the project is shown in Fig. 3. The milestones are flagged. It can be seen that with the initial Jet Grouting, additional settlement of 19.3mm was experienced due to further disturbance of the weak soils near Bored Pile Tips, although care was exercised to reduce such disturbances to the minimum by initially drilling far from the Bored piles. The Girders had to be releveled again by Jacking.

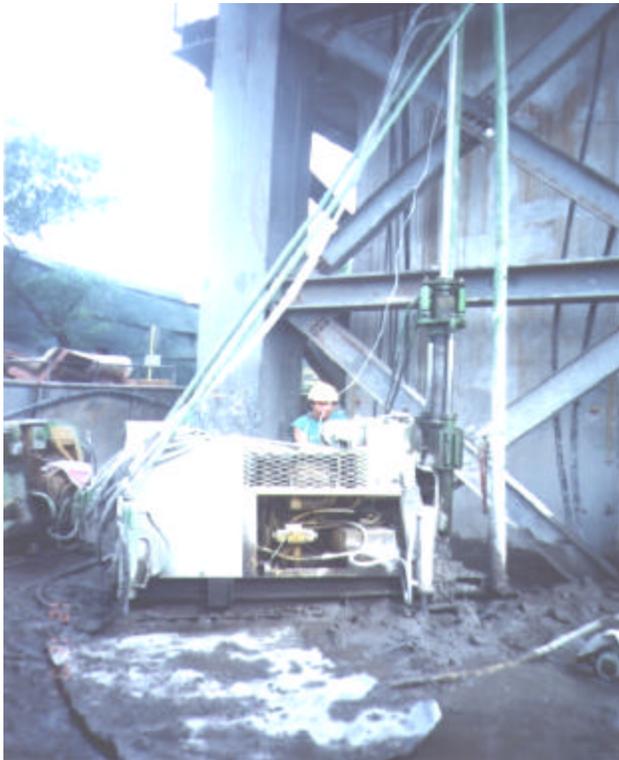
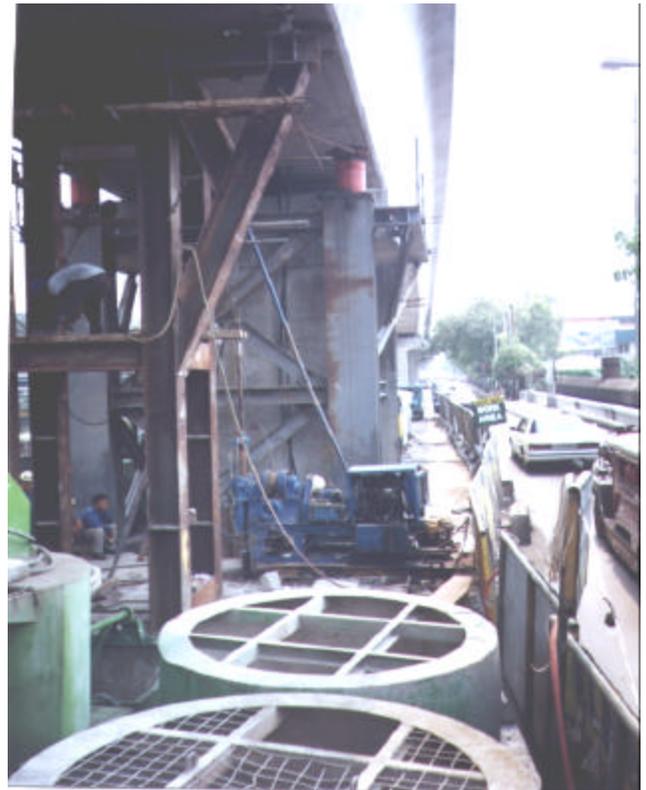
Fig. 6. Jet Grouting Machine set up under Pier

Fig. 7. Jet Grouting Equipment Layout

A set up of the equipment underneath the Girders is shown in Fig. 6 and 7. The equipment is a Double tube Jet Grouting System with Grout injected through a side jet protected by a compressed air shroud.
