THE TRANSVERSE DIKE SPILLWAY NO. 3 FAILURE

- An Investigation into the Failure Mechanism

EMILIO M. MORALES, MSCE ¹¹

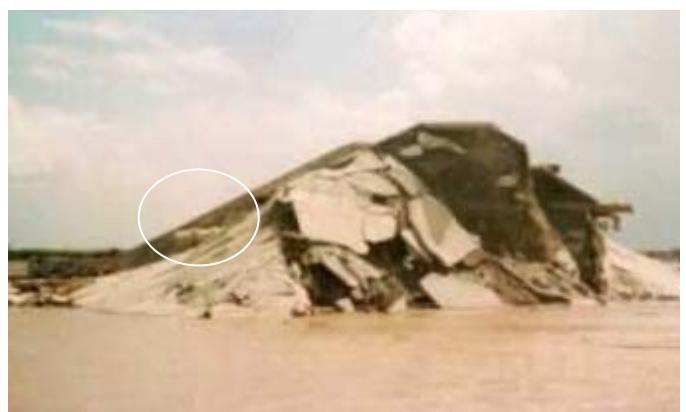
Photo A

The picture below shows what remained of the spillway after a 67 meter section was breached. A closer look at this photo, looking West, shows that the Dike core was internally eroded with the Downstream and upstream armor RC facing collapsing into the core.

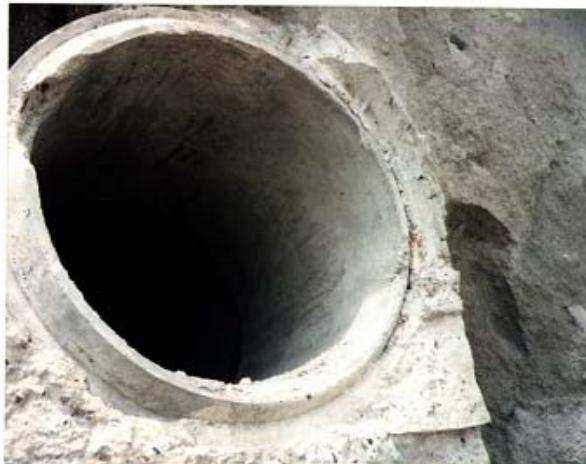
Photo No 1 clearly shows the absence of rebars on the bedding concrete. The bedding has completely sheared off at the joint allowing massive inflows inside the Dike Core creating the massive caverns shown in the subsequent photos. Note that the mortar grout had been removed at one side.

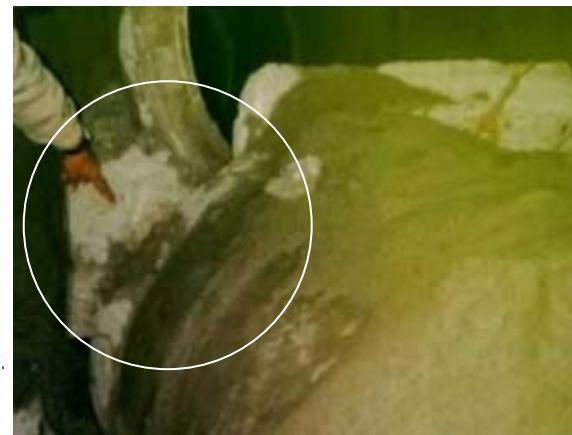
Photo No 2 also shows the same absence of rebars in the supposed to be reinforced Concrete bedding. As can be noted, most of the pipe breakages were at the critical pipe joints where the pipe is weakest. However, total collapse and full breakage of the pipe joints could have been prevented or minimized if the concrete bedding reinforcement had been placed in accordance with the plans and details.....

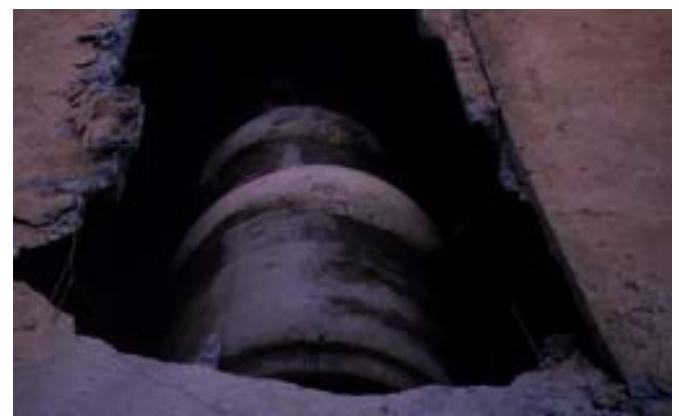
Photo No 3 shows that the Mortar grout that was placed when compared to the scale of the pipe indicates that the mortar grout dimensions specified in the plans were not followed. Also, note that the thickness of the Mortar grout at the top of the pipe is very much

different only at a short distance away from the top along the sides. Why this is so is not clear to this investigator.

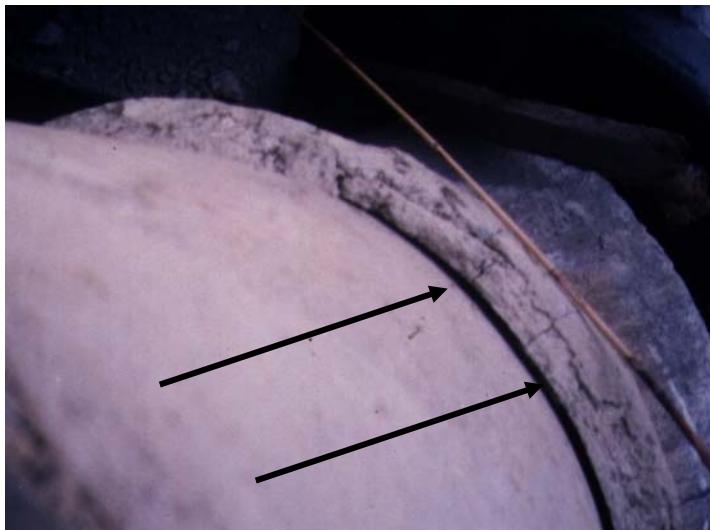
Photo No 4

These photographs (Nos 4 & 5) show the poor quality of the mortar grout. Note the gap that was neatly debonded from the pipe body in Photo No 4. Although not clearly discernible in this photo, the mortar grout is relatively less than the 100 mm thickness specified in the plans.

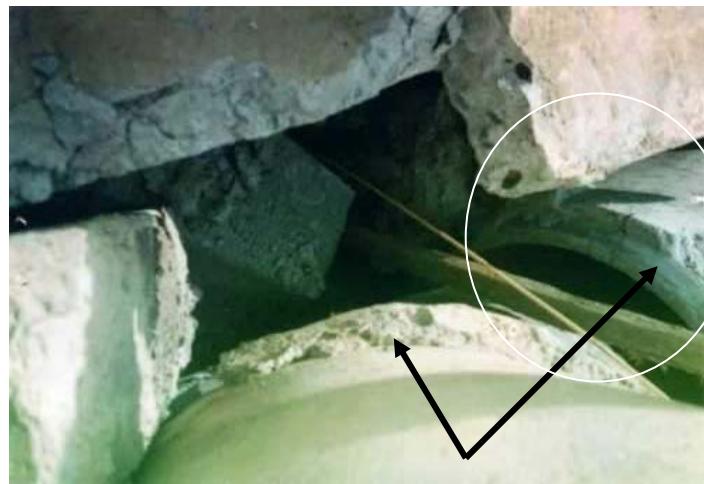
Photo No 5 more clearly illustrates the quality of the Mortar grout as laid and its actual thickness.

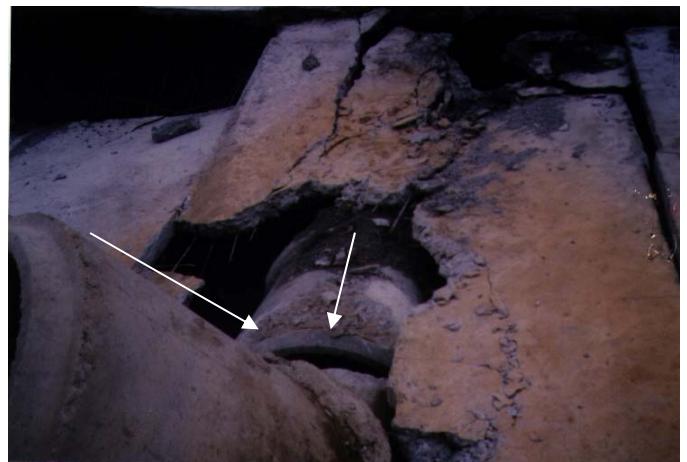
Photo No 6

This photo No 6 shows the pipes tilted upward as it daylights at the outlet end downstream. The armor facing has collapsed inward. Also to be noted in this photo is the cavity formed underneath the facing and alongside the pipes.

The pipe tilted inward indicates that internal collapse occurred rather than an outward failure that could have been caused by excessive build-up of pressure inside the dike core otherwise, the pipes could have been pushed downward and out.

This clearly suggests that undermining from internal erosion caused by Internal leaks along the pipe joints was the most probable cause. These leaks which became critical as the leaks progressively got bigger eventually led to the critical breakage of the unreinforced concrete bedding at the pipe joints causing massive pressurized flows inside the dike core.

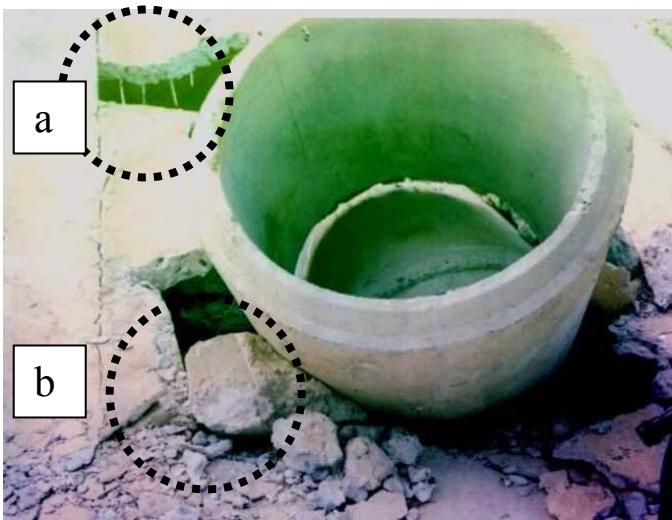
Photo No 7

This photo No 7 shows the pipes also tilted upward at the outlet end downstream as in previous photo No 5. The pipe inside also shows undermining of support more clearly visible in the previous Photos (Photo No 3 & 6) above.

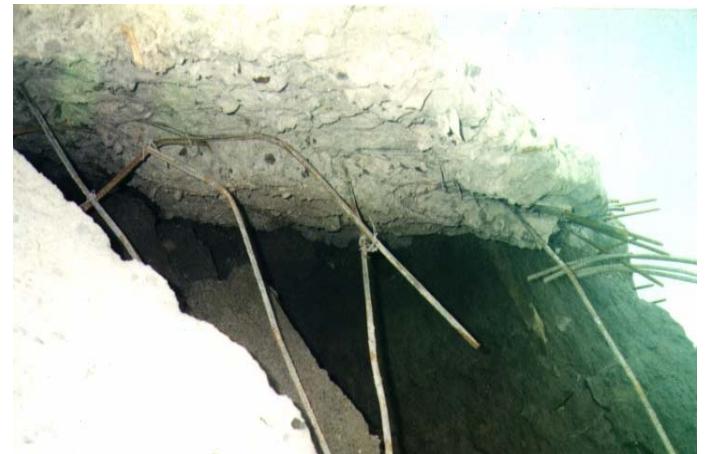
Photo No 8 show the rebars as laid out in the actual construction. The rebars are all at the bottom or nearly at the bottom of the RC Facing where it is ineffective in resisting lateral forces from internal water pressure. Our structural analyses indicated (*See section 4 pages 5-6*) that if the rebars have been correctly placed in the middle, the facing slab would have been adequate to sustain the lateral pressure buildup due to the rise in the phreatic surface inside the dike core. No analysis is required to show that the facing concrete would fail once the tensile capacity of the Concrete (which is very minimal) is reached. This explains the disintegration of the concrete facing as can be seen in Photo A.

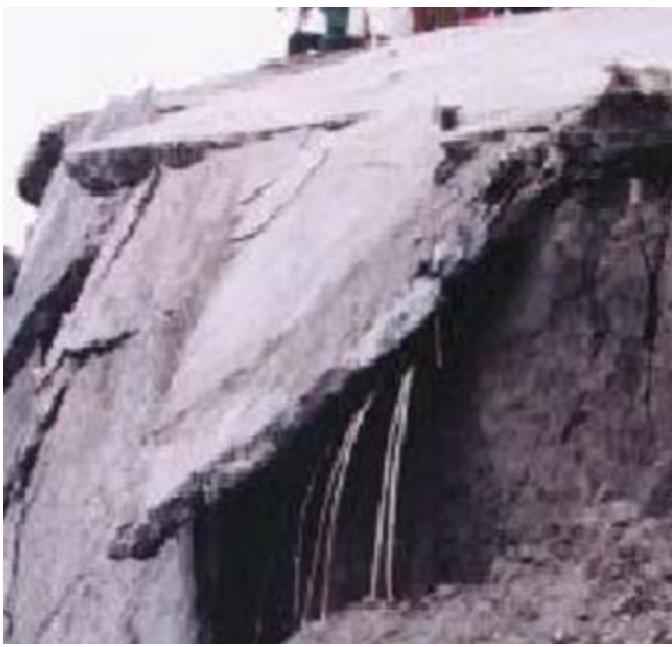
Photo No 9

This photo shows the rebars debonded from the RC Facing . The picture also show that the rebars were not placed in the middle of the Facing but rather at the bottom portion of the slab where it is ineffective in “reinforcing” the concrete facing.

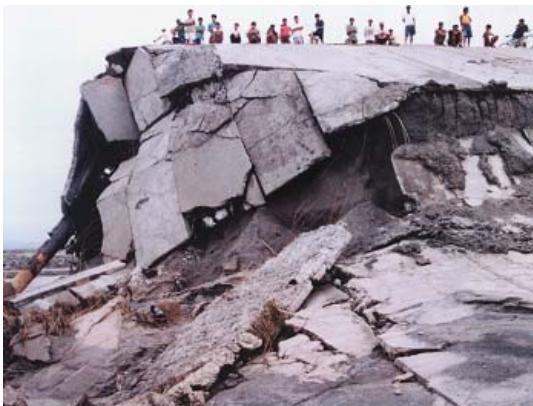
3. The wrong placement of the rebars (Nearly at the Bottom of Facing) gave the facing very minimal flexural resistance against the outward lateral pressure build-up causing failure of the concrete in tension and in places completely debonding the reinforcement from the concrete slab. This explains the breakup of the facing into small slab panels as shown below (see also Photo “A”):
