The Traditional Type 1 Joint in Structural Steel - A Clear and Still Present Danger

Authors: Emilio M. Morales MSCE ¹
Mark K. Morales M Sc ²

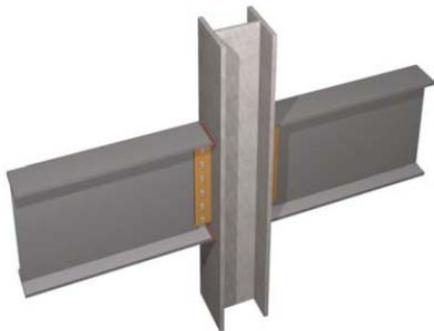
(a) Type 1 'traditional' moment connection.

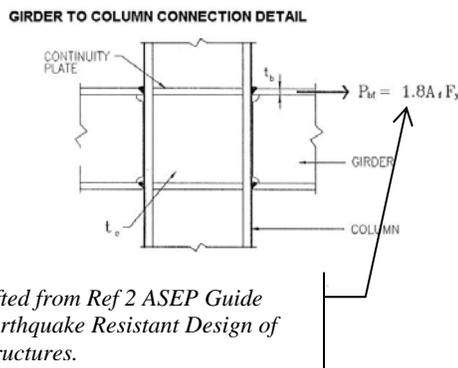
The ASEP Guide “*Earthquake Resistant Design of Structures*” 1991 Edition contained in Chapter 4 “*Recommended Structural Detailing Practices*” the Traditional *Type 1* joint detail as connection Detail 4.29 on page 182.

Type 1 Joint in ASEP Guide

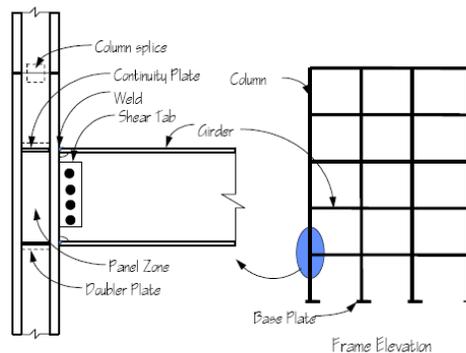
Figure 2-1 Elements of Welded Steel Moment Frame

The foregoing is the same detail incorporated in the ASEP Guide “*Earthquake Resistant Design of Structures 1991 Ed*” unfortunately; this guide has not been replaced nor superseded to reflect the current State of knowledge regarding the problems associated with this connection detail in the light of the Northridge Earthquake experience.

The failures are primarily attributed to a fundamental flaw in the standard code-prescribed welded-flange bolted-web

connection and the extreme ground motion at the site.^{8]}

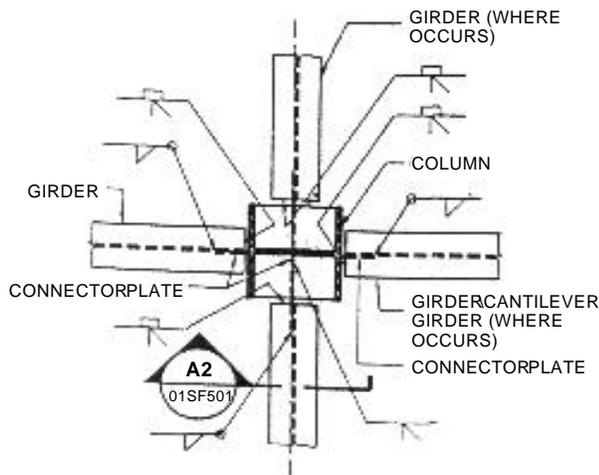
Based on the details as shown above, taken from a scan of the drawings, the following are main features of the Joint detail:

1. A plug weld is used to weld the Girder flanges supported by a backing bar or spacer directly to the column flanges.

2. Connection plates (“Stiffener”) at the level of the top and bottom flanges were incorporated within the joint panel as stiffener plates.
3. The girder web is connected to the column by means of connector plates butt welded to the column using a Vee weld.

The foregoing figure shows that the joint connection details are similar to or identical to joint connection details in use prior to the *Northridge Earthquake*, which consists essentially of Girders being framed into columns by full welding of the Girder Flanges to the corresponding column Flanges or webs by butt or groove welds. These welds were very much in use pre 1994 until detailed post Northridge Earthquake damage evaluation indicated that something was terribly wrong with these joints.

It is suggested that Engineers who have not done so yet, consider abandoning the Type 1 Joint in favor of the Type 3 Joint in order to correct the potential problems associated with the former.

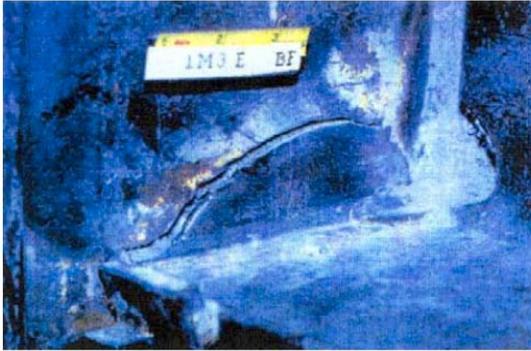
Failure was initiated in all instances by the incomplete fusion flaw as provided by the backing bar and its gap to the column flange. This constitutes a pseudo crack, which becomes a stress raiser during cyclic loading leading to crack initiation.

The open notch tip of the weldment where the backing bar is placed simulates a crack in itself. During cyclic dynamic loading, the crack propagates into the weld metal into the Heat affected zones (HAZ) and unaffected zones.

Figure 4. Brittle failure in ‘traditional’ steel frame connection observed after Northridge Earthquake.

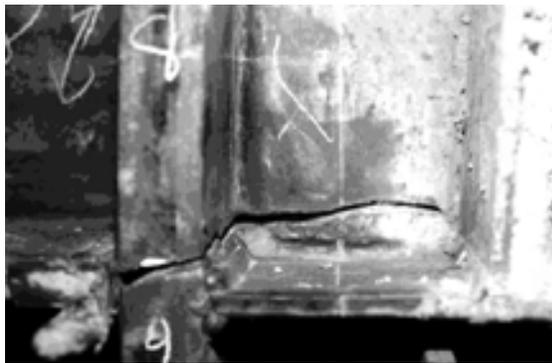
Damage to Column very Severe

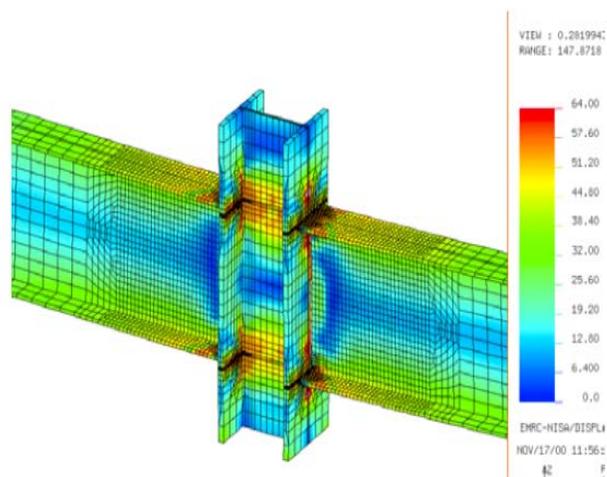
“The traditional (Type 1) moment connection experienced high-order bi-directional localized plastic strain at the weld root at critical junctures between the girder and column, which is one of the causes of premature brittle fracture. The strain patterns shown in Figure 16 clearly indicate the propensity for this phenomenon. The strain gradient is particularly pronounced at the mid plane of the girder near the weld and weld access hole.”

“Yield stress near the weld access hole and flange weld is exceeded early on in the loading. The strain plots near the weld access hole and flange weld show the stress reversal in the free edge of the girder flange, which is typical for traditional moment connections and a causative factor in fractures initiated from this region of the flange weld. This can potentially lead to fractures either in the flange or, far more critically from the progressive failure perspective, in the column flange. It is primarily this mode of failure that effected moment connection damage in the Northridge earthquake.”

(a) Close-up of von Mises stress, ksi.

Type 1 Connection Showing Von Mises Stress Contours

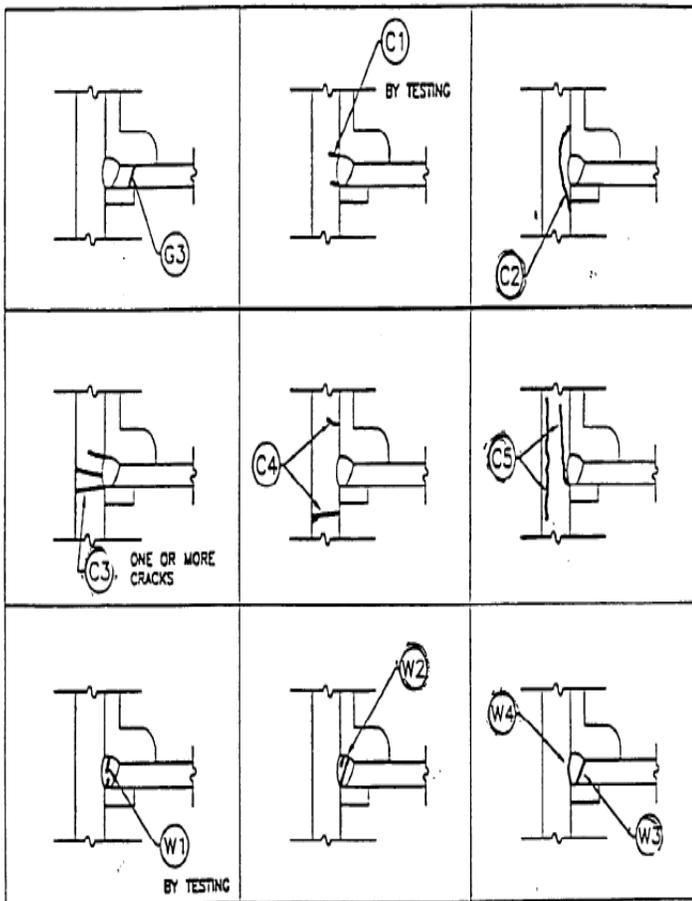
The figure below shows the various types of damage to Joint Panel Connections sustained during the *Northridge Earthquake* sustained by the *Traditional Type 1 Joint Detail* after *Youssef*. *(The numbered arrows point to the Cracks)*

NOTE:
Numbered bubbles point to cracks

Figure 2 - WSMF Damage Types (Youssef et al.).
