INNOVATIVE FOUNDATION SOLUTIONS SAVE THE DAY

Author **EMILIO M. MORALES, MSCE**
Principal
Organization EM²A Partners & Co.
Address QUEZON CITY, PHILIPPINES

CASE I – SETTLEMENT OF BORED PILE FOUNDATIONS

CASE 2 – WAREHOUSE CLUB ON VERY POOR SOILS

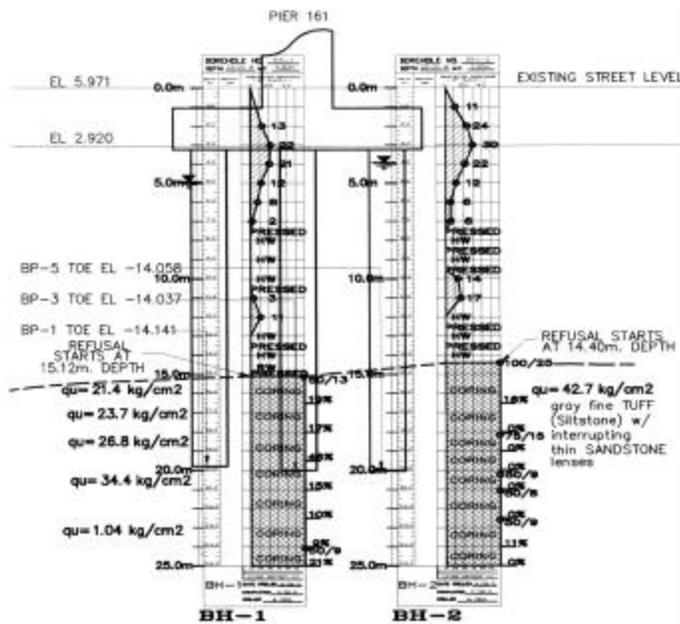
The check Borings (Fig. 1.0 below) indicated that the overburden soils are relatively poor to very poor beyond 7 meters as shown in the Soil Profile below for BH-1 and BH-2.

Fig. 1 – Soil Profile near Pier Foundation

As can be seen, refusal was only encountered at a depth of 15.12 meters and 14.40 meters below existing Natural Ground Line.

The ensuing check borings (Fig 1.0) verified that the Bored Pile tips were resting on very soft soils or on highly weathered bedrock.

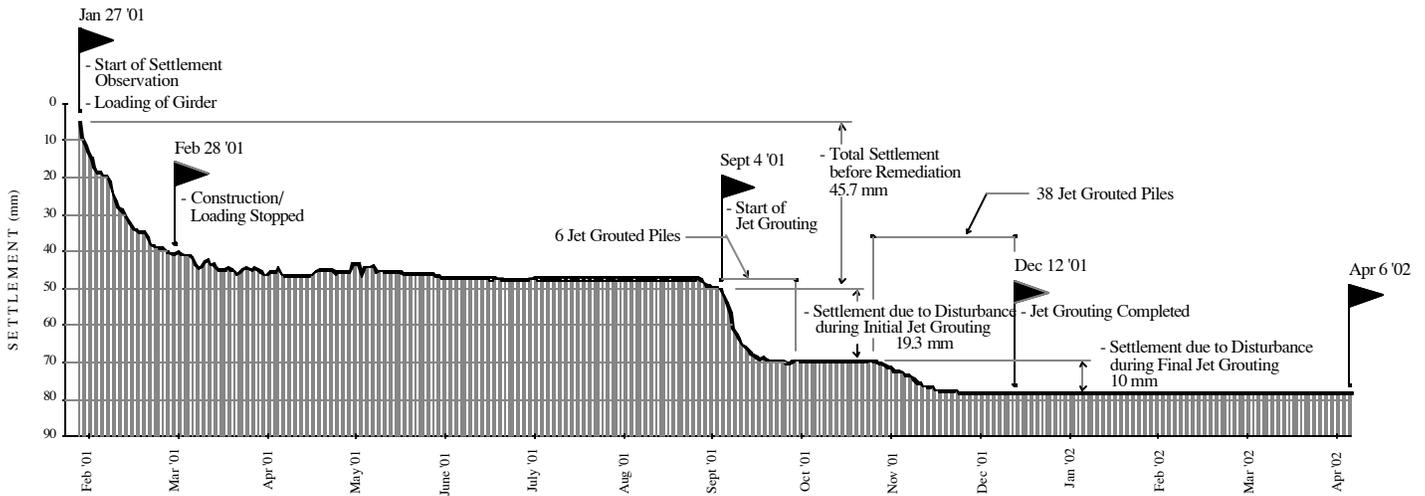
Fig. 3 – Settlement History

The settlement record for the project is shown in Fig. 3. The milestones are flagged. It can be seen that with the initial Jet Grouting, additional settlement of 19.3mm was experienced due to further disturbance of the weak soils near Bored Pile Tips, although care was exercised to reduce such disturbances to the minimum by initially drilling far from the Bored piles. The Girders had to be releveled again by Jacking.

Grouting of 38 Piles on November 1, 2001. Only 10mm additional settlements were recorded. The Jet Grouting was completed on December 12, 2001.

Immediately upon detection of on-going settlements, formal settlement monitoring and recording was started 27 January 2001. Because of continuing high rate of settlement, construction loading was halted on February 28, 2001. Heavy Structural Steel scaffolding was placed to support the Girders and Jacking releveled the Girders. Still settlements continued but at a reduced rate resulting in a total of 45.7mm settlement of the Pile Cap.

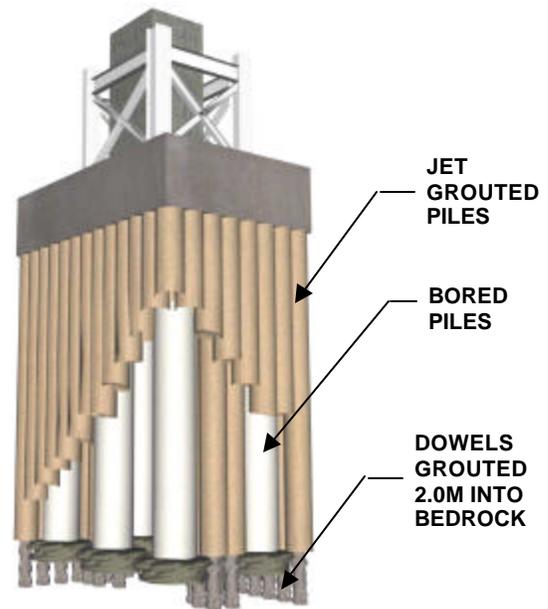
Fig. 4 – Section showing remediation procedure

The Jet Grouting solution was finally selected because it offered a far better assurance of stability during seismic loadings. As shown in Fig. 3 the solution consisted of providing a Jet Grouted Wall around the footprint of the Pile Cap and at several interior locations as shown in the plan.

This Jet Grouted Curtain Wall in Secant Pile arrangement would assure full assumption of the load from the Bored Piles while at the same time increasing resistance to sliding and overturning.

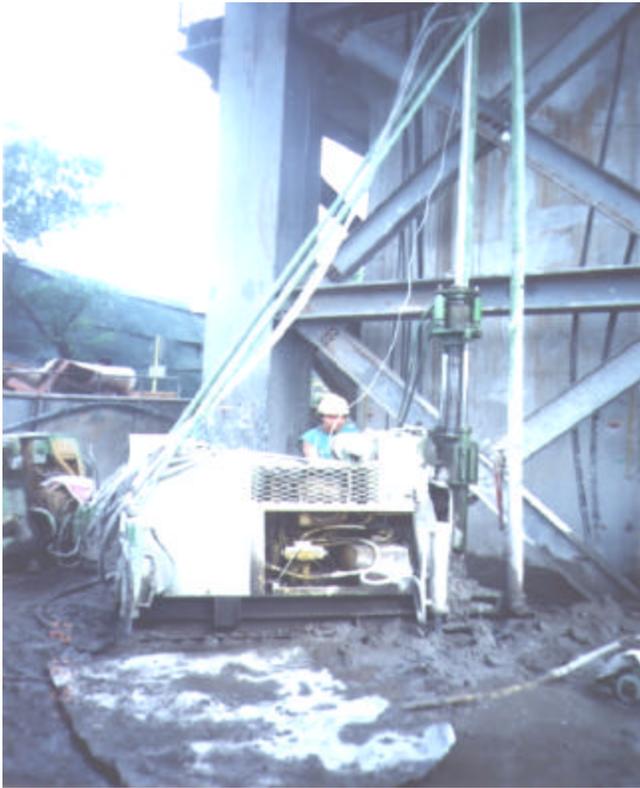
Fig. 5 – Jet Grouting Machine set up under Pier

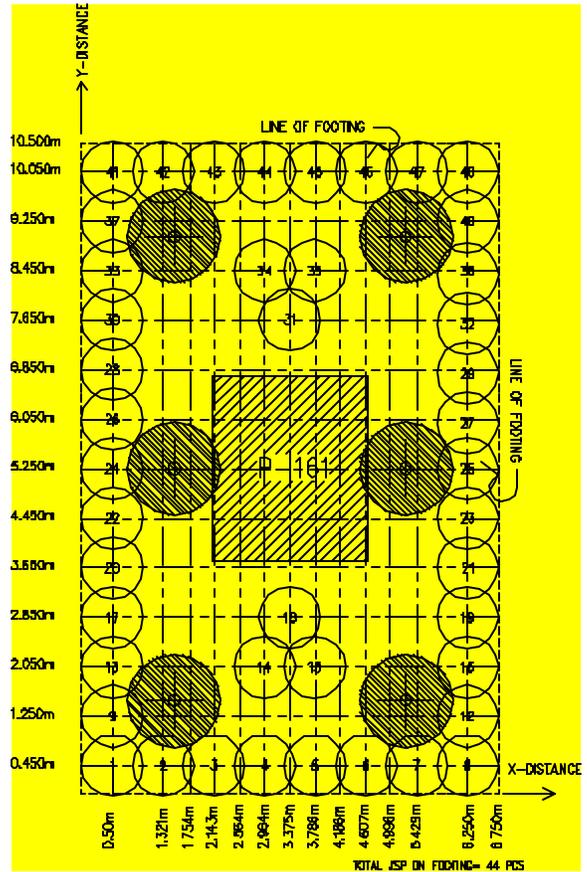
Fig. 7 – Layout of Remediation using Jet Grouting

In addition, each of the Jet Grouted Piles were reinforced at the center by 25mm \varnothing rebars which were inserted by re-drilling the Jet Grouted Piles (JGP) and extending 2.0 meters beyond the Soil/Bedrock interface into competent Bedrock. The drilled hole and dowel bar were subsequently regouted effectively doweling each JGP into the Bedrock. Expansive admixture and higher strength mix was used to grout the rebar to the Pile Cap. This provided extra shear capacity over and above that provided at the Pile Cap/JGP Interface.

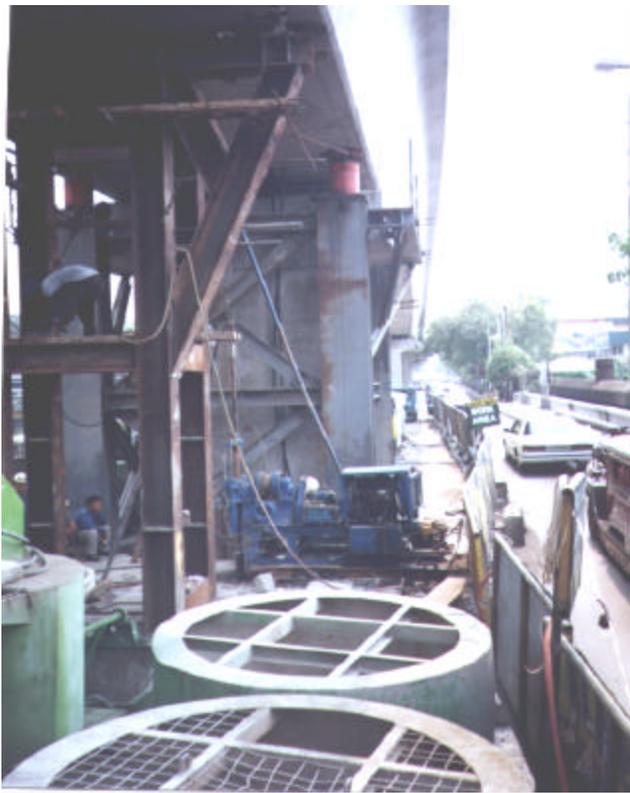
Fig. 6 – Jet Grouting Equipment Layout

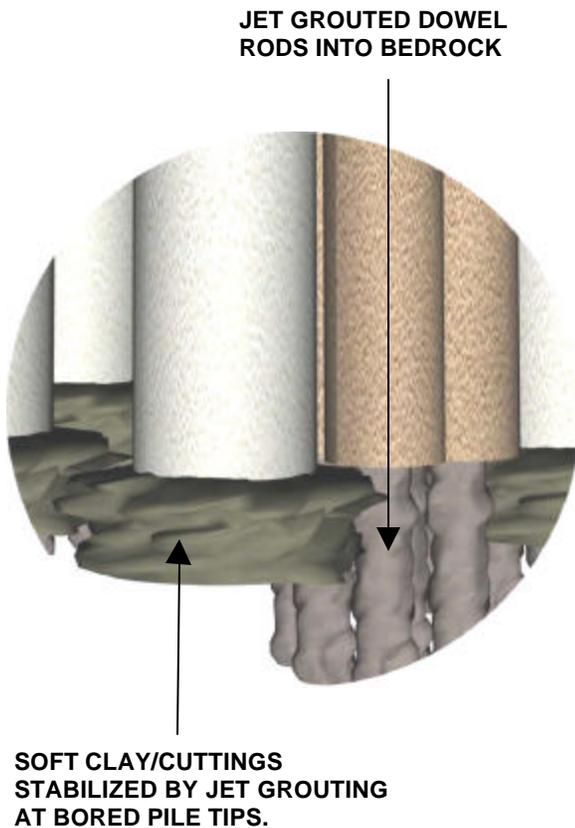
Although the Jet Grouted Curtain wall would be more than adequate to support the total foundation loading, the Project consultants required that the existing Bored piles be redrilled at the center to allow for the insertion of Grouting equipment in order to grout the pile tip. This would ensure that once the "Soilcrete" has cured, the Bored pile tips would be resting on solidified ground. This was accomplished after the initial JGP installation and was done initially in areas where the JGP have substantially cured and attained full strength.

The solidification at the tip of the Bored pile is shown in the figure below:

Fig. 8 – Bored Pile Tip Detail After Grouting

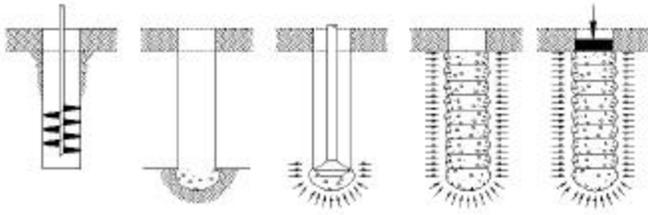
Our company offered a value engineering alternative using Geopier® foundation. The proposed solution consisted of installation of about 1900 Geopier of 3.0 to 3.5 meter length supported on the very soft soils. The Geopier foundation system is a Rammed Aggregate Pier system using patented technology. Installation is done in the following sequence shown by the fig below:

Fig. 9 – Sketch of Geopier® installation procedure

Due to the installation procedure, which consisted of ramming the aggregates using a patented beveled rammer, lateral prestraining and precompaction of the surrounding soils were realized. This prestraining and prestressing effect resulted in significant increases in lateral stresses around the Geopier perimeter resulting in very significant stress transfer by skin friction to the surrounding soils. Only very minimal residual stresses due to the loading were transferred to the Geopier tip thus resulting in large reduction in settlements of the Geopier.

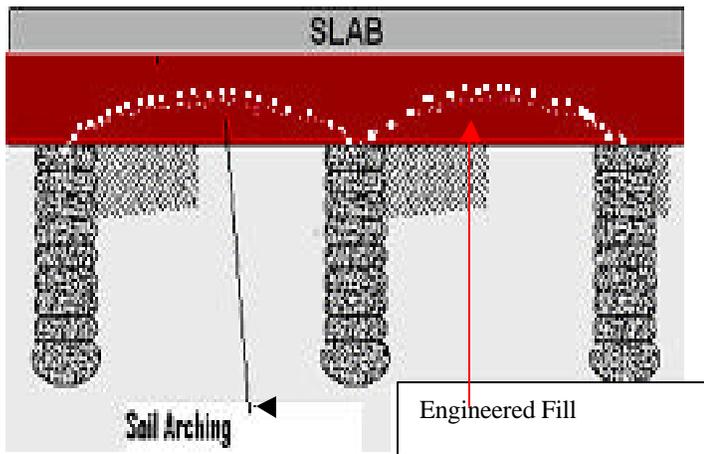
The suspended structural framing Support of the merchandise and warehouse floor was totally eliminated. In its place, a very innovative slab support system was substituted. The slab support system consists of a 1.0 meter thick Engineered Granular fill supported on Geopier at 3.0 meter on centers by arch action. The arch action transfers the entire load onto the Geopier elements. This enabled the floor slab to be designed as a conventional slab on Grade with reduced reinforcement and with very minimal settlements.

Fig. 10 – Sketch showing slab support using Engineered fill to transfer floor loads to Geopier by Soil arching.

As a result of this Value Engineering alternative, the construction time was shortened by two (2) months allowing for an earlier opening of the Warehouse club. This was because the heavy suspended floor was totally eliminated and the floor was designed as slabs resting on a compacted engineered fill instead. The engineered fill in turn is supported on Geopier spaced at 3.0 m on centers by arch action.

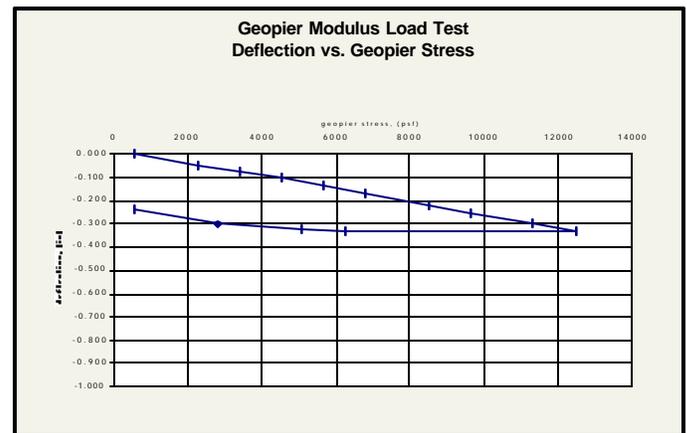
Fig. 11 – Modulus Load Test Graph

The Stiffness modulus values of installed Geopier elements are determined by full-scale modulus tests. The test is performed by applying pressure in gradual increments over the full cross-section area at the top of a Geopier element. The stiffness modulus value corresponding to 100% of the design stress applied to the top of the pier is determined based upon the load test results, and is typically expressed in English units as pci, and in metric units as MN/m³. The Geopier modulus

load test is not a bearing capacity type test, such as a pile load test. Rather, it is a settlement test to determine a conservative value of pier stiffness. The Geopier foundation system design uses the stiffness modulus value measured at the point of maximum anticipated design stress; i.e., at 100% design top of Geopier stress (or at the maximum acceptable deflection) from the modulus load test results. Geopier modulus tests are normally performed to a top of Geopier stress equal to 1.5 times the maximum design stress. The purpose of applying load to more than the design stress is just to observe the Geopier element deformation characteristics at higher stress levels.

As can be seen from the above a total of only 0.218mm settlement was obtained under full service load and that failure was not reached at 1.5 times the maximum service load. A residual settlement of only 0.231mm was left after unloading of the Modulus test.

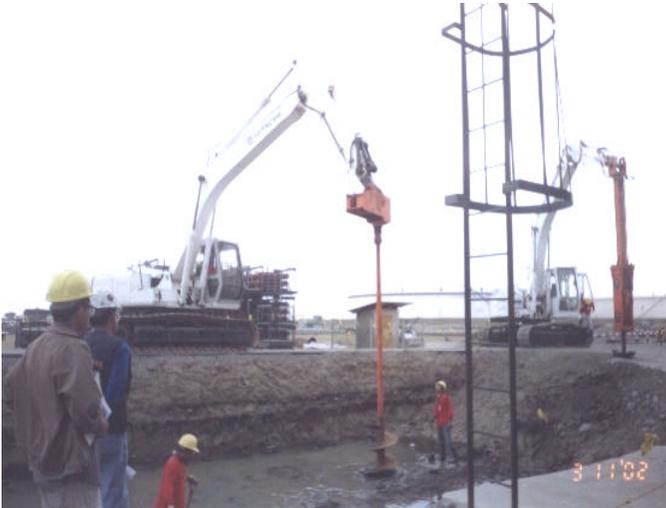
Picture 1 - Auger Machine for excavation of hole

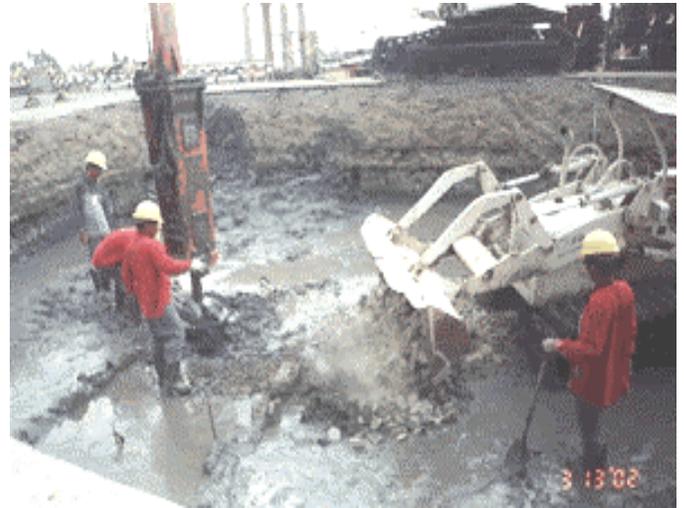
Picture 2 - Aggregate being lowered into hole in increments

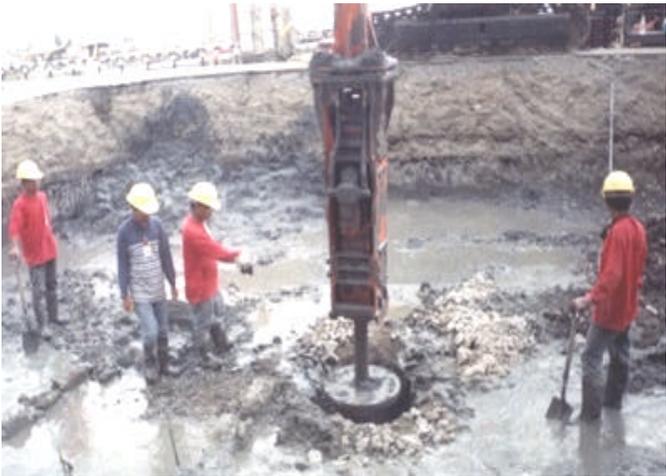
Picture 3 - Hydraulic Hammer with Bevelled Rammer being lowered into the hole

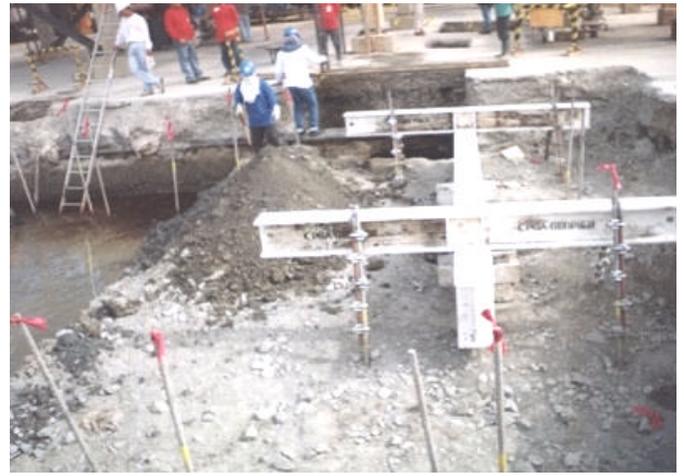
Picture 4 - Geopier Modulus Load Test Setup

As part of the execution, a Modulus load test was performed on a production Geopier in order to determine the settlement under the full service load. The Geopier Modulus test is similar to the setup used in a pile load test but the interpretation is different.
