The Stability of Slopes

Emil M. Morales MSCE

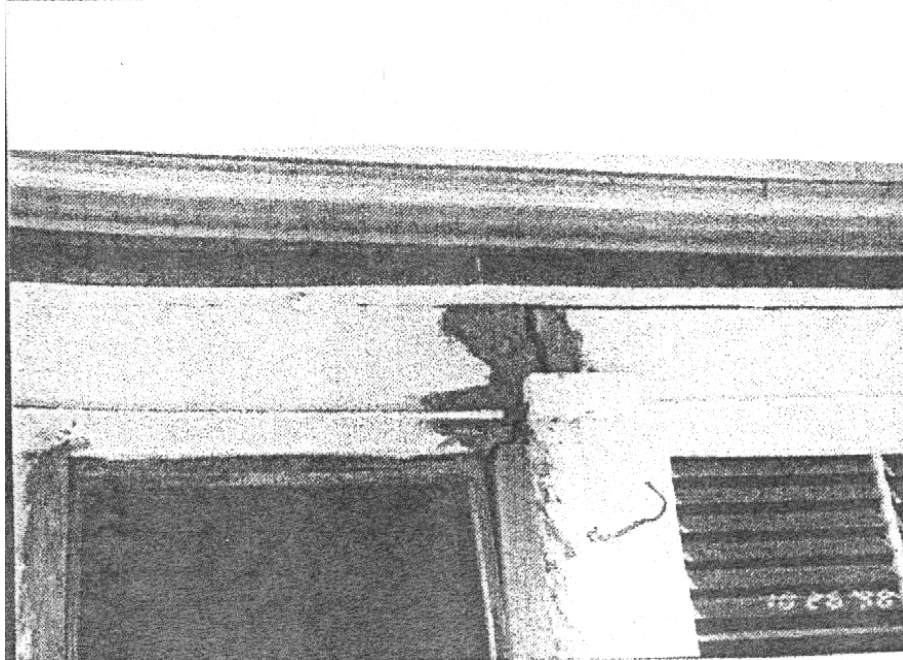
- Fast tracked development of low cost housing on slopes sometimes lead to oversights that are costly to repair.
- In this case, the contractor neglected quality control in Fill compaction along the slopes leading to Gross settlements and subsequent distress in numerous housing units.

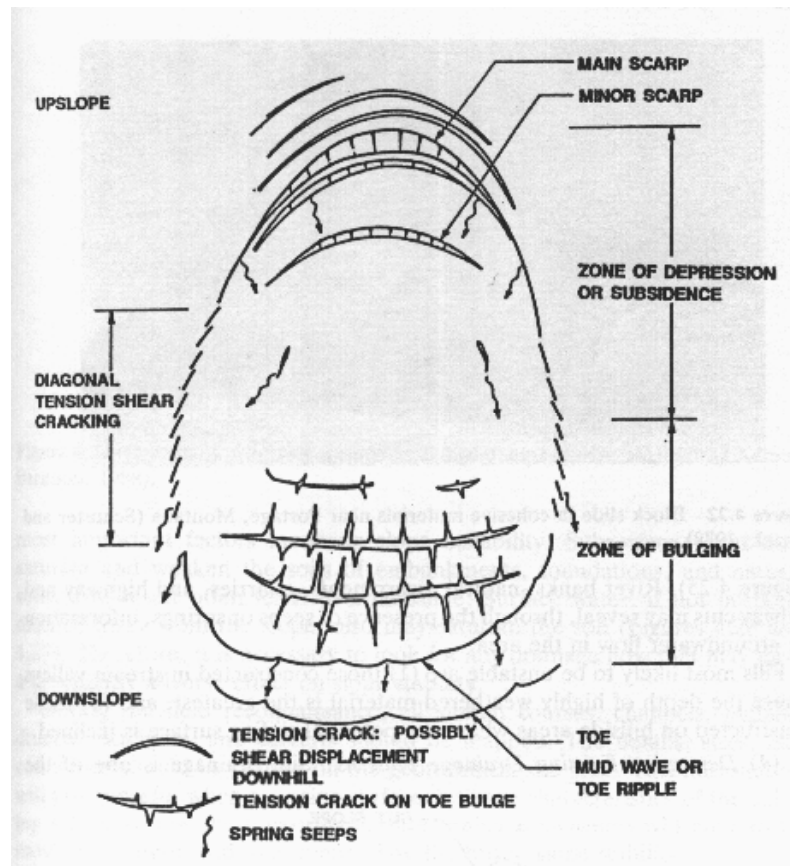
Typical Plan of a Slide Zone.

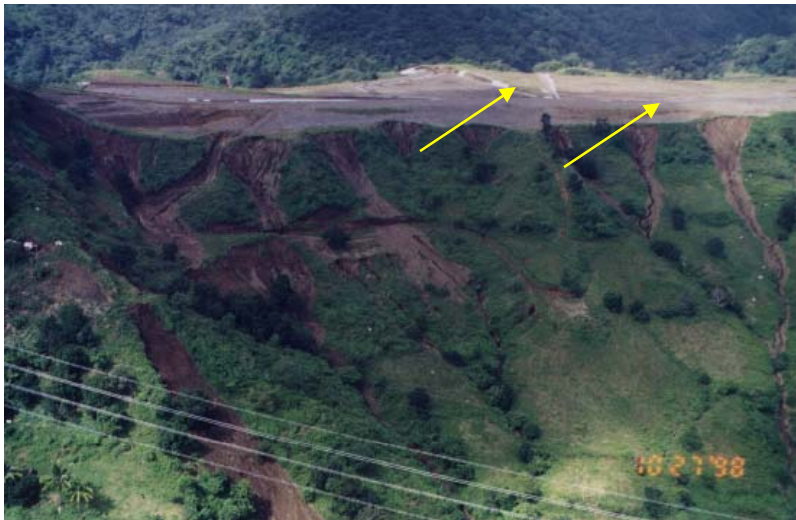
Concentrated discharge of Runoff combined with damage to the vegetative cover leads to bigger problems. Rilling leads to gullying which destabilizes slopes and leads to massive landslides.

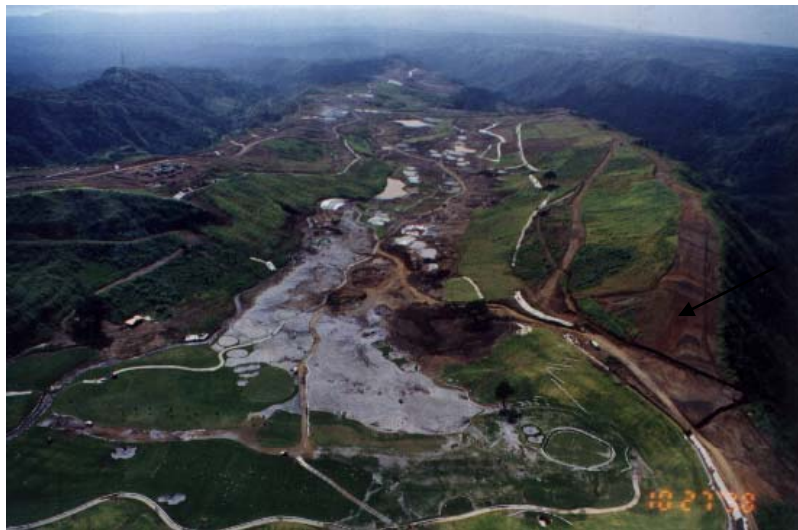
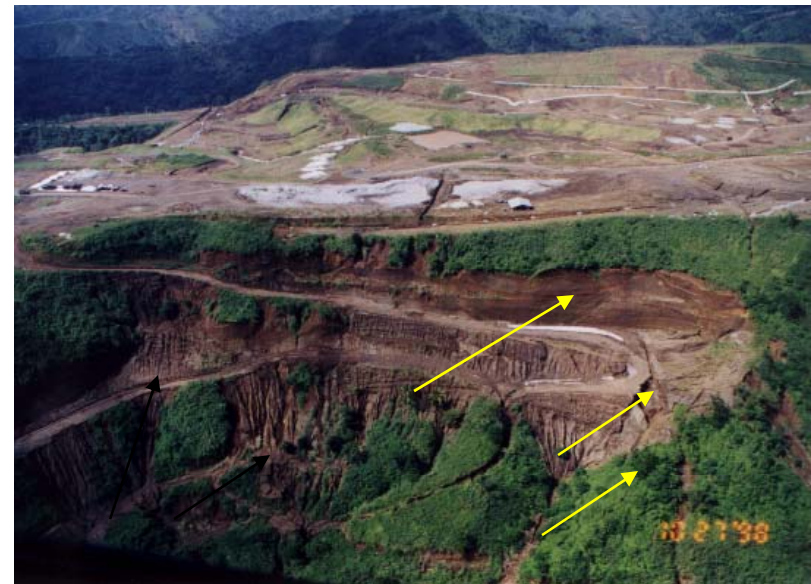
Destruction of the Natural Vegetative cover by end dumping and pushed over materials help to accelerate erosion and the Propagation of Landslides

The result is massive erosion and slide initiation.

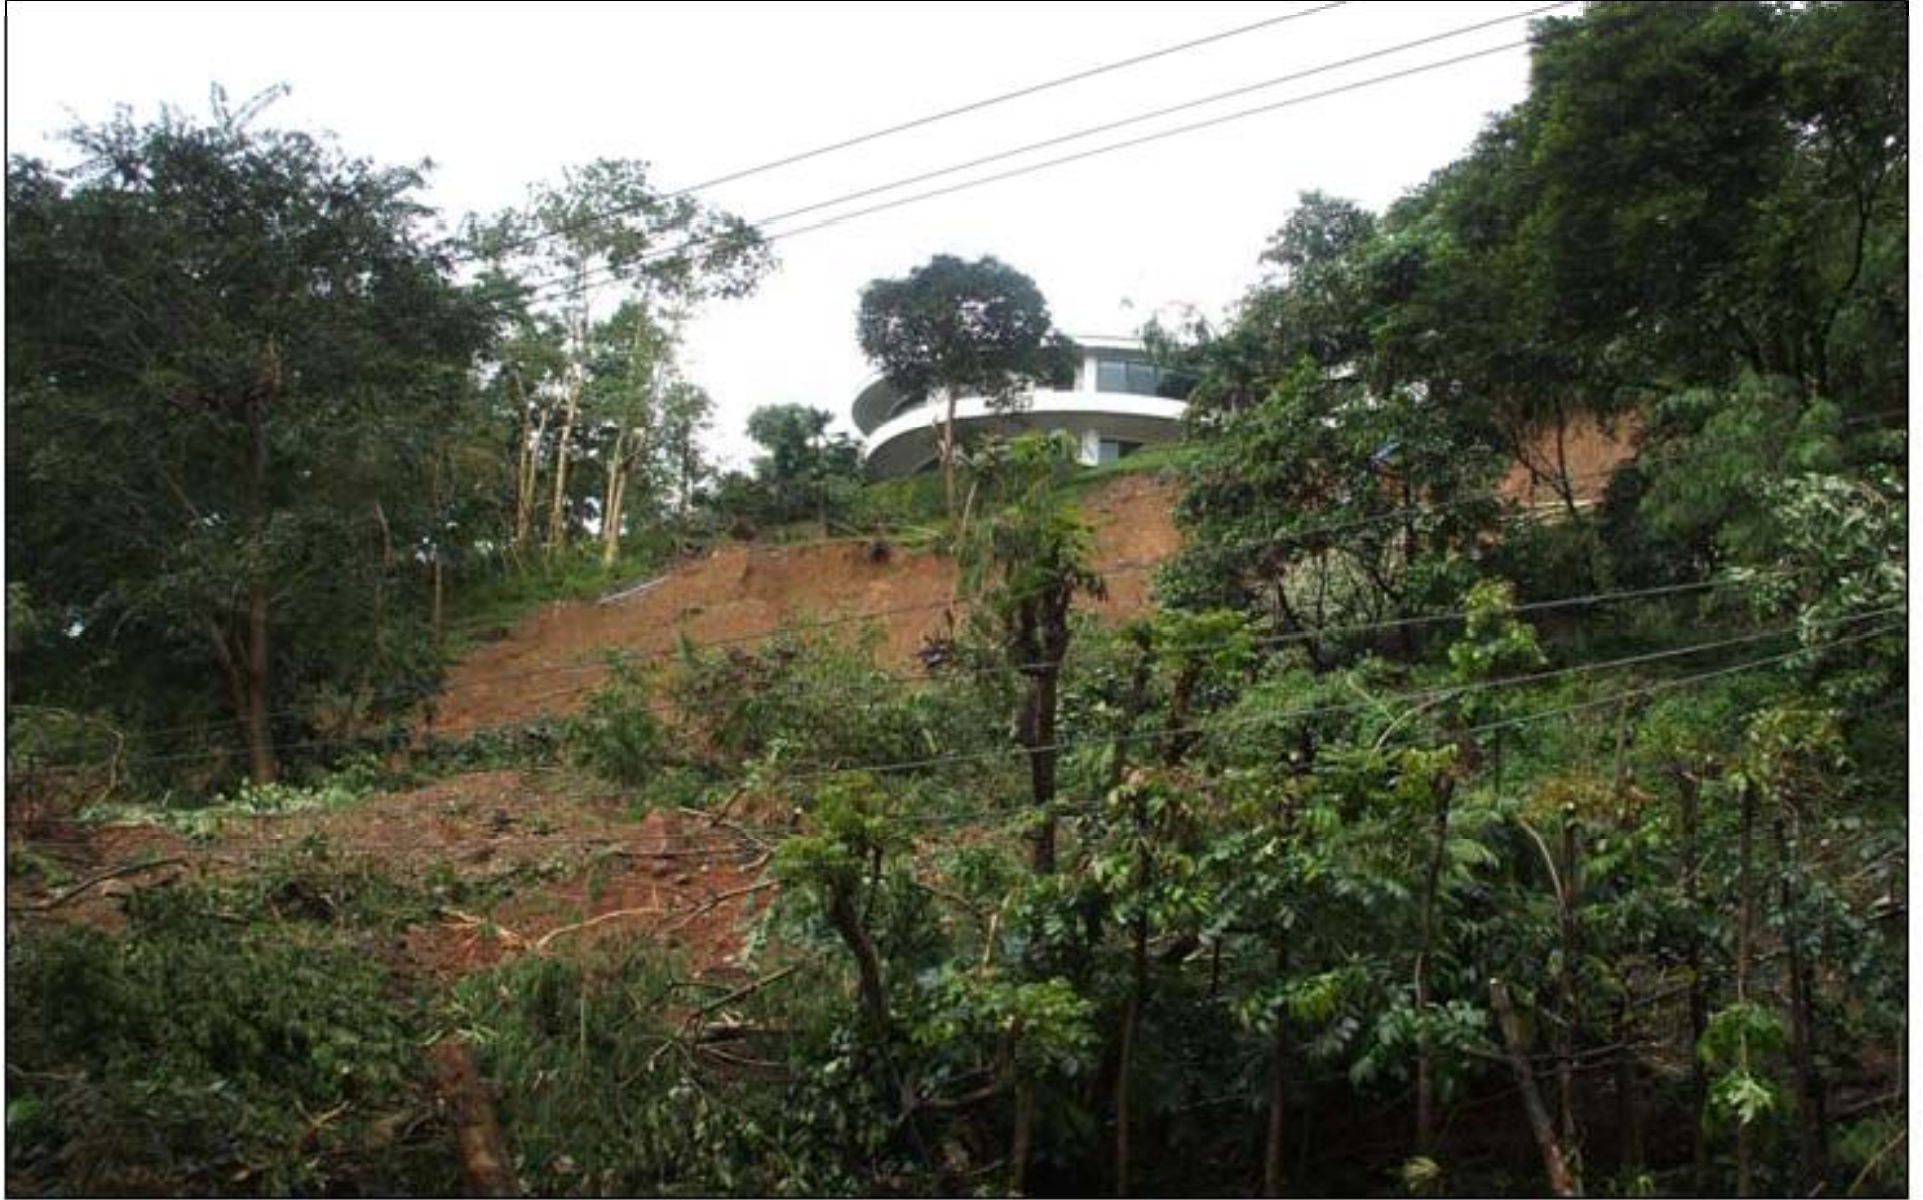
ANTIPOLO LANDSLIDE

Sumulong Highway was Blocked for over a Week

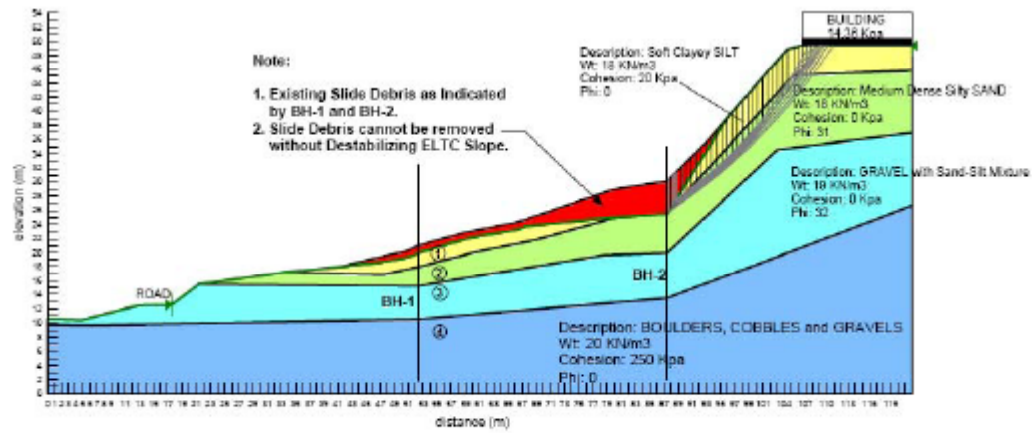
Factor of Safety: 0.631

FOS = 0.631 NG

STATIC CONDITION

Eugenio Lopez Training Center
Method: Ordinary
Horz Seismic Load: 0
Vert Seismic Load: 0

SLOPE FACE ACTUAL CONDITION OF SLIDE DEBRIS REMOVED BASED ON ACTUAL SOIL PARAMETERS

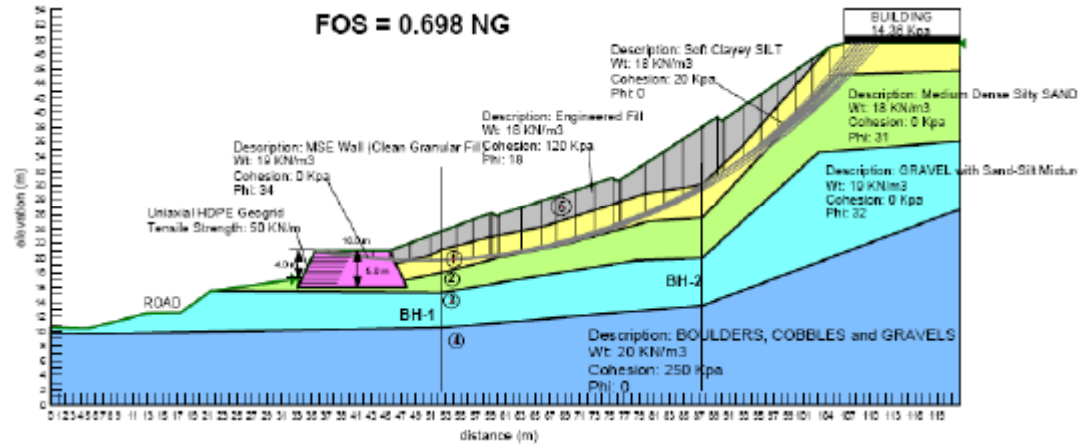
Factor of Safety: 0.698

STATIC CONDITION

Eugenio Lopez Training Center
 Method: Ordinary
 Horiz Seismic Load: 0
 Vert Seismic Load: 0

ORIGINAL SLOPE GEOMETRY USING ACTUAL SOIL PARAMETERS

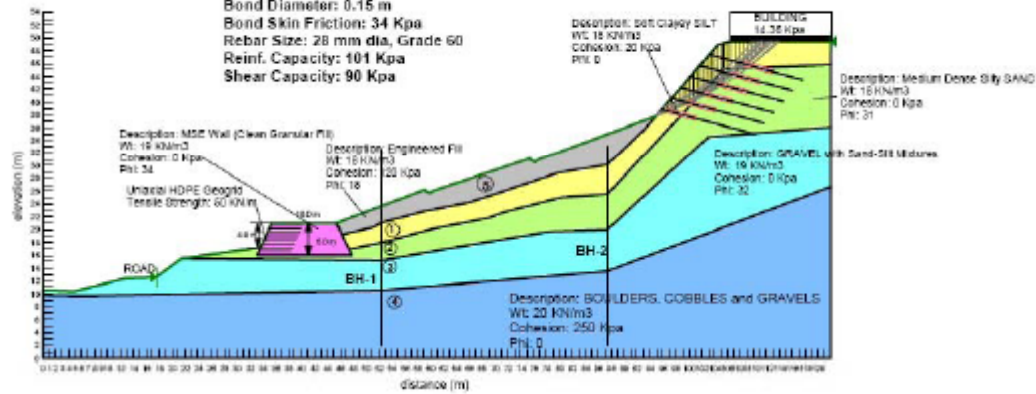
Factor of Safety: 1.421

STATIC CONDITION

Eugenio Lopez Training Center
 Method: Ordinary
 Horiz. Seismic Load: 0
 Vert. Seismic Load: 0

Soil Nail Length: 15.0 m
 Horz. Spacing: 1.7 m
 Vert. Spacing: 1.7 m
 Bond Diameter: 0.15 m
 Bond Skin Friction: 34 Kpa
 Rebar Size: 28 mm dia, Grade 60
 Reinf. Capacity: 101 Kpa
 Shear Capacity: 90 Kpa

FINAL REMEDIATION CONFIGURATION WITH SOIL NAIL BASED ON ACTUAL SOIL PARAMETERS

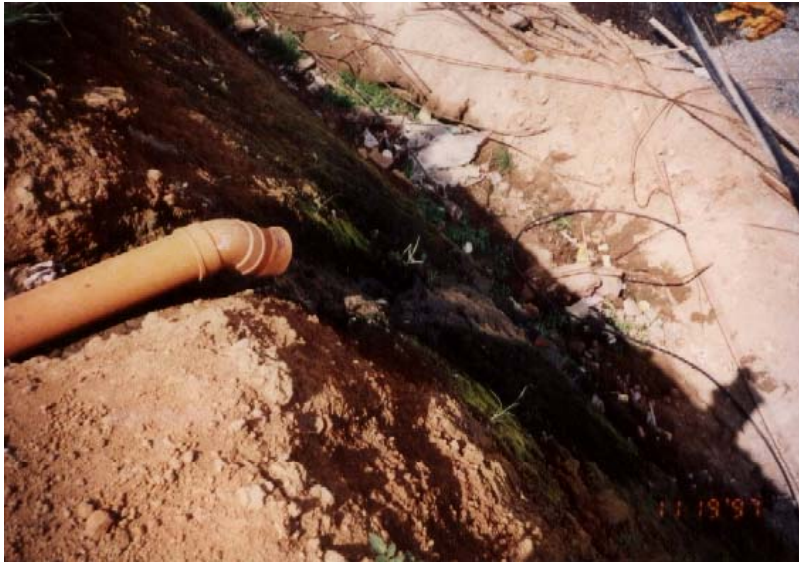
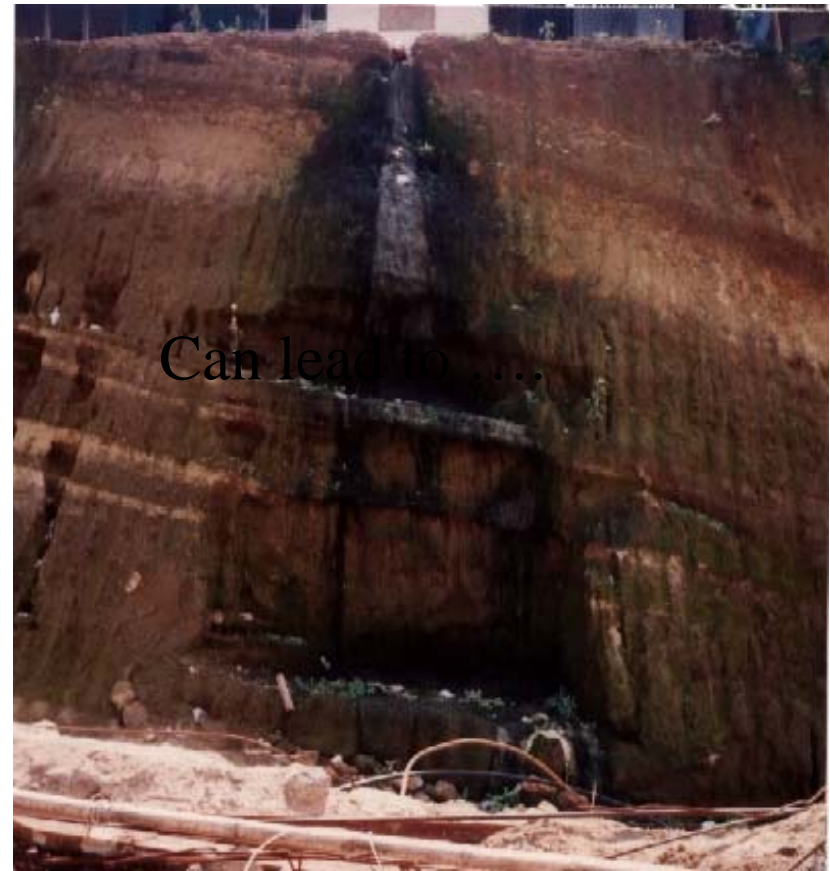
An innocent pipe discharging down slope.....

Slope erosion and

Producing a dangerous condition.

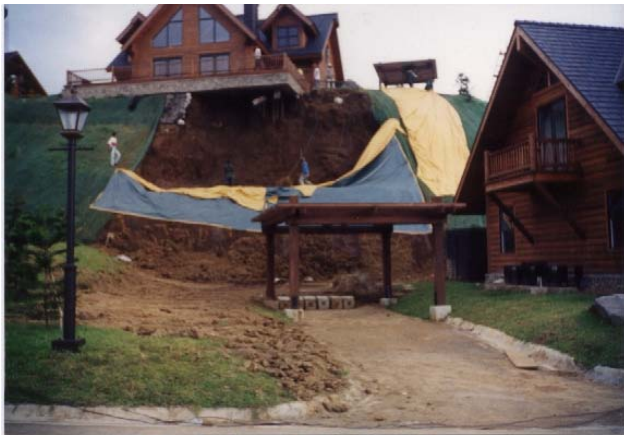
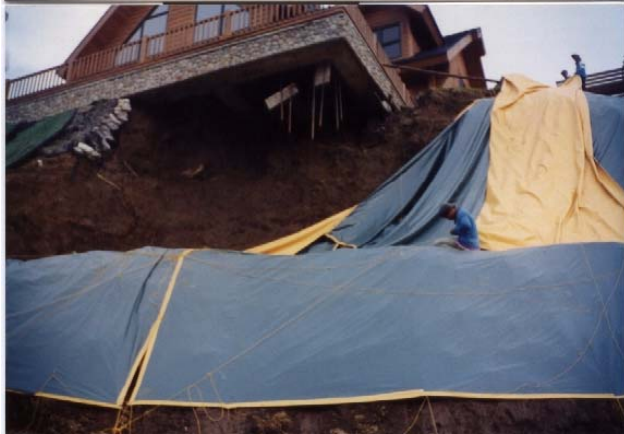
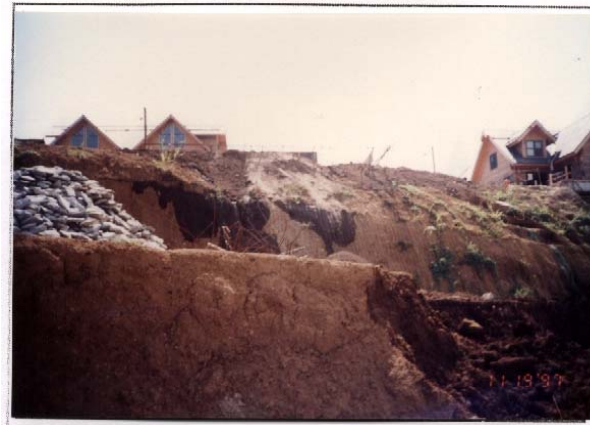
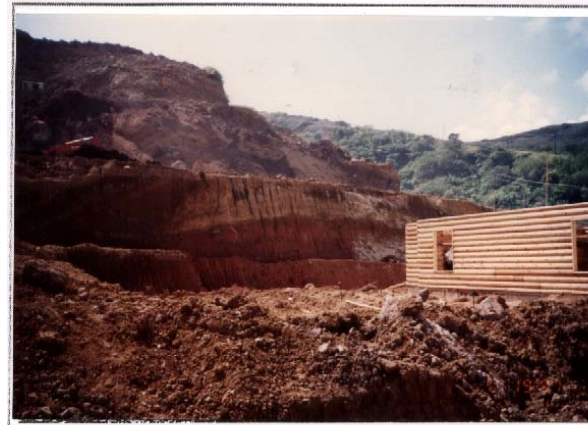
Sheetwash and Rilling could lead to Gully formation. All this needs is to reverse the slope at the crest to prevent costly collapses. These slopes would need benching or Gravity Walls augmented by Biotechnical Slope Protection.

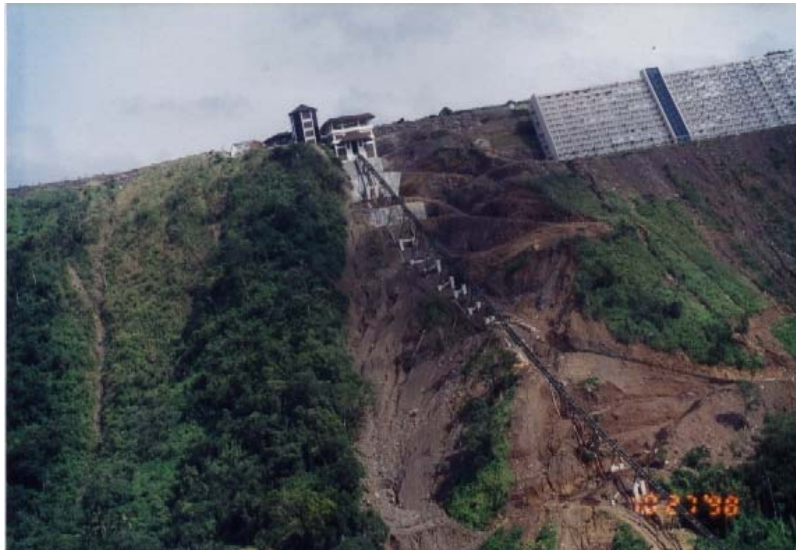
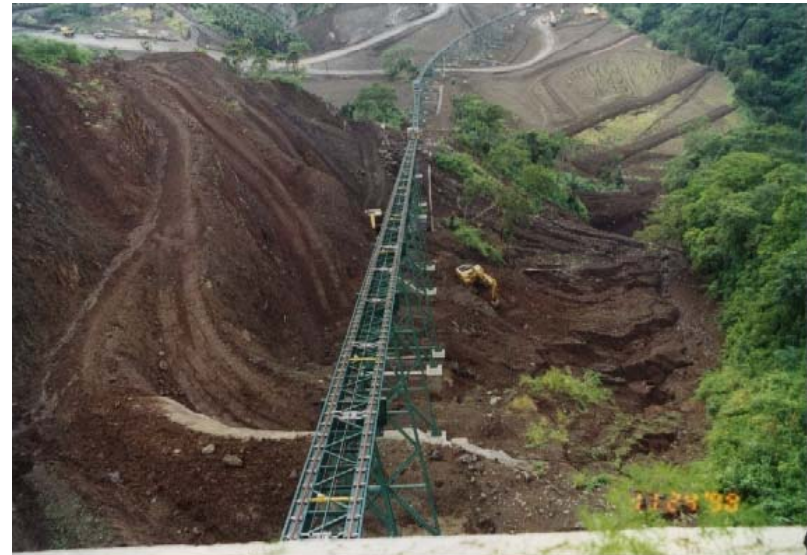
This is a classic case where engineering plans were not followed and uncompacted pushed over materials were deposited along the slopes..

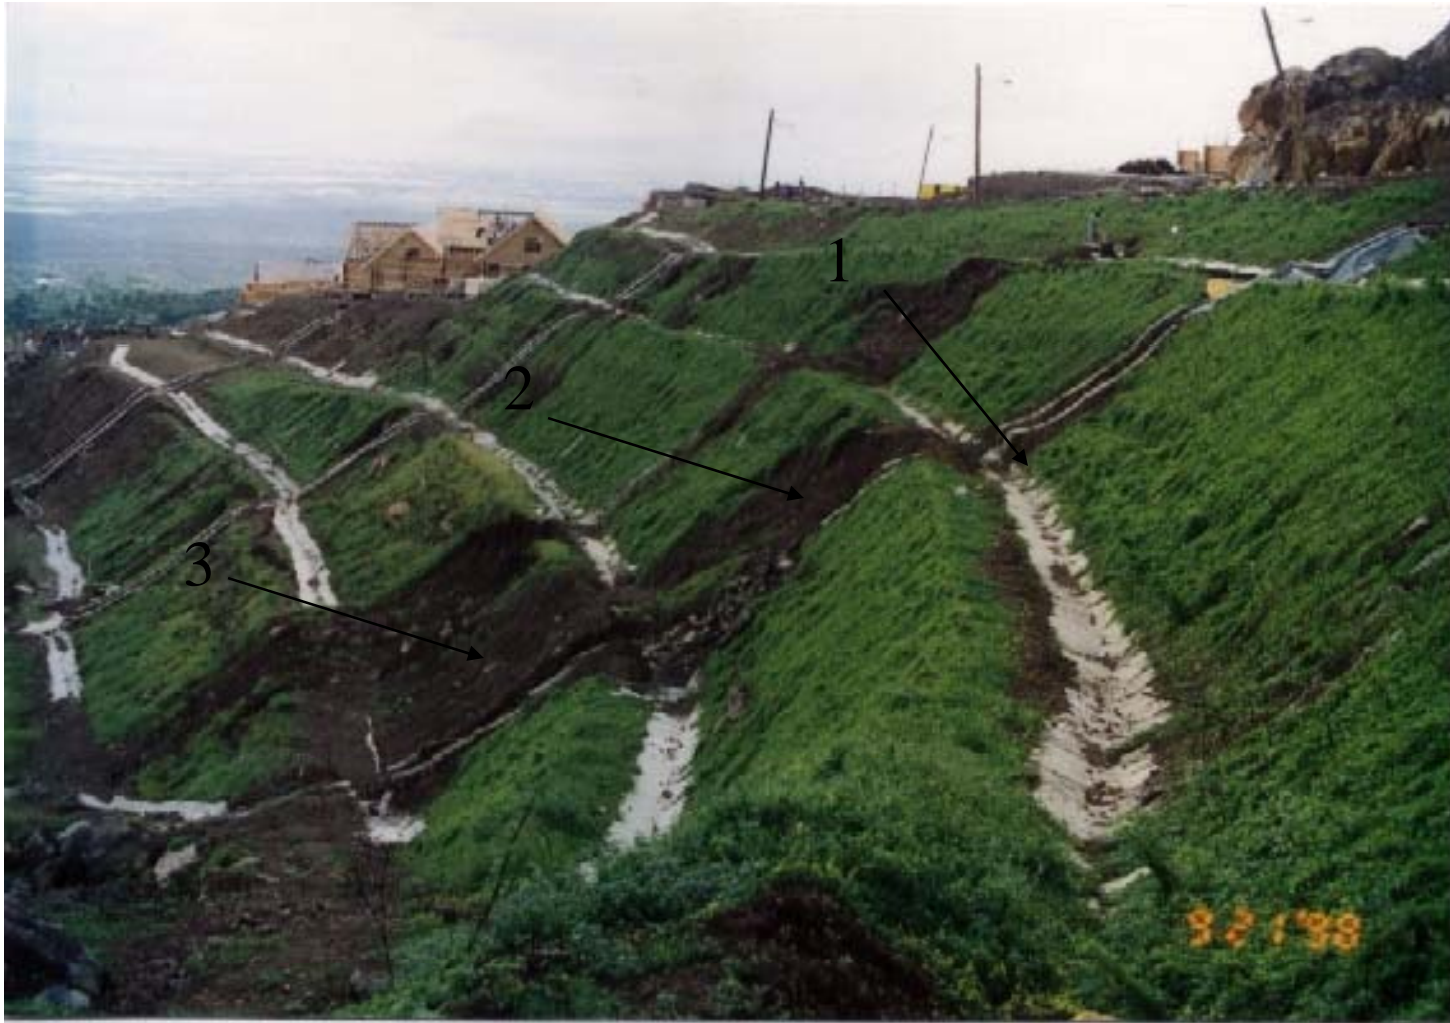
- Extensive Remediation using Biotechnical Measures and Chevron Drains needed to be deployed

- 1-Chevron drains discharges into ski Jump and overflows
- 2- Spillage outside of ski Jump causes undermining of Structure leading to collapse.
- 3- Spillage spreads wider causing more progressive damage.

Extensive drainage and Biotechnical protection measures needed to be introduced to save the slopes. Even with this intervention, mistakes in construction of the remedial measures led to costly reworks. Chevron drains were not properly laid out and overflows were not prevented causing sheetwash erosion and reconstruction of the slope drains.

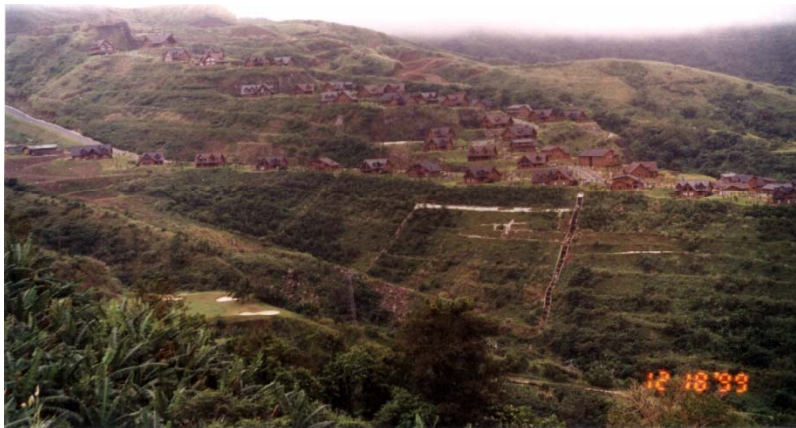
Finally, successful stabilization of slopes without the use of “hard” Structures through Biotechnical means and use of adequate drainage.

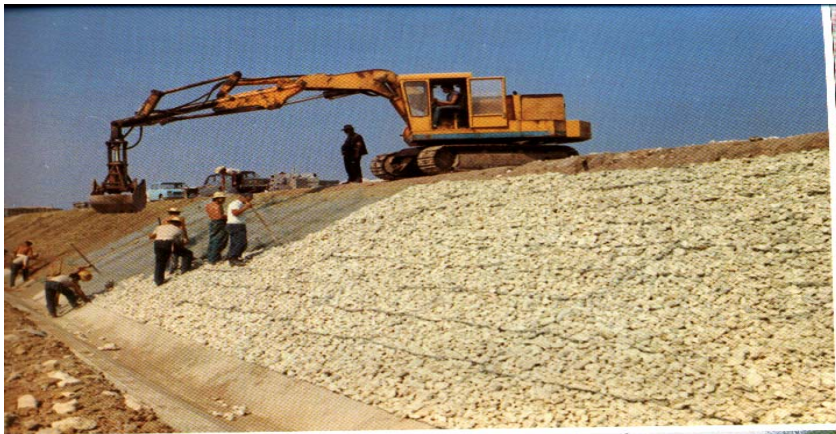
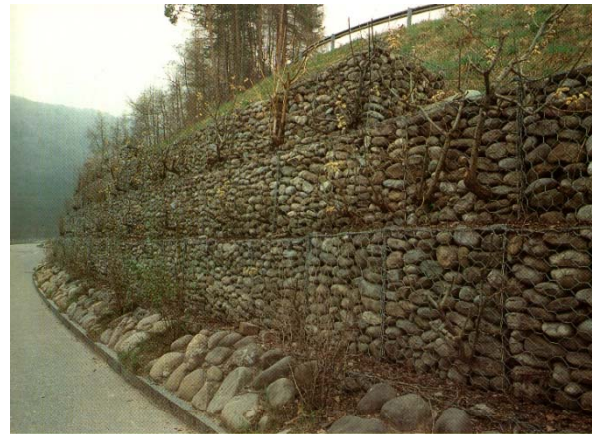
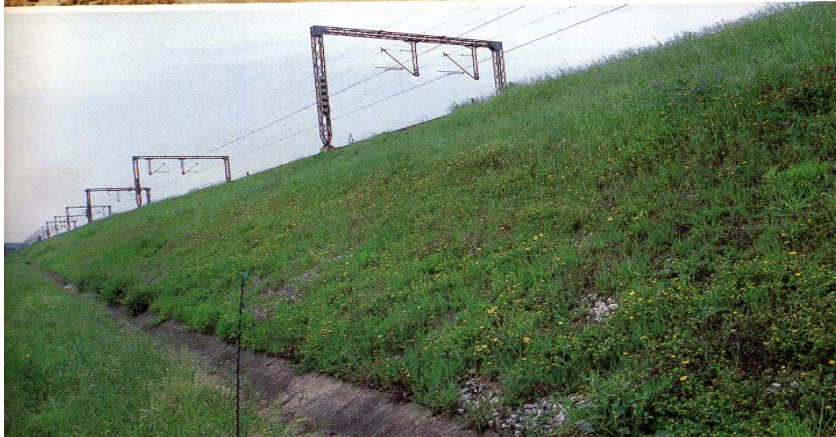
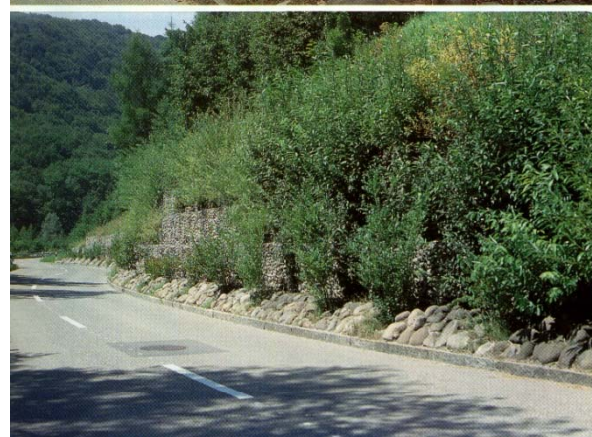
Harsh Engineered Slope protection can be made environmentally friendly with use of Plantings

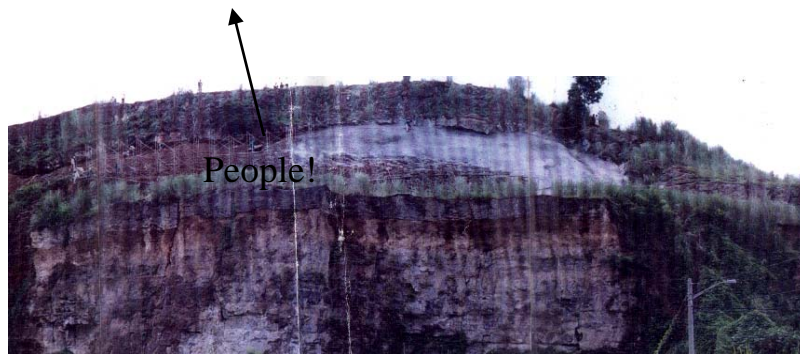
Highly weathered soils sandwiched by otherwise competent bedrock can cause problems when eroded, leading to rockfalls and topples.

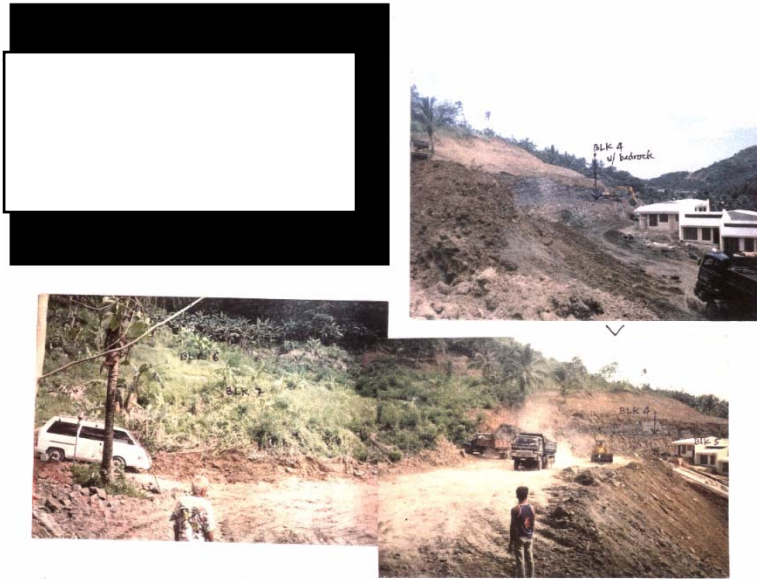
Control of Groundwater

- This land development filled up a gully without providing relief for water springs and conveyance of surface runoff.
- Heavy rainfall mobilized the uncompacted fill causing abandonment of several housing blocks.

This specific project proved to be very costly to the developer because slope failures and careless and uncontrolled dumping of spoils resulted in demolition of about 20 low cost housing units. We had to come in to study remediation to avoid further damage and also reclaim the failed slopes.

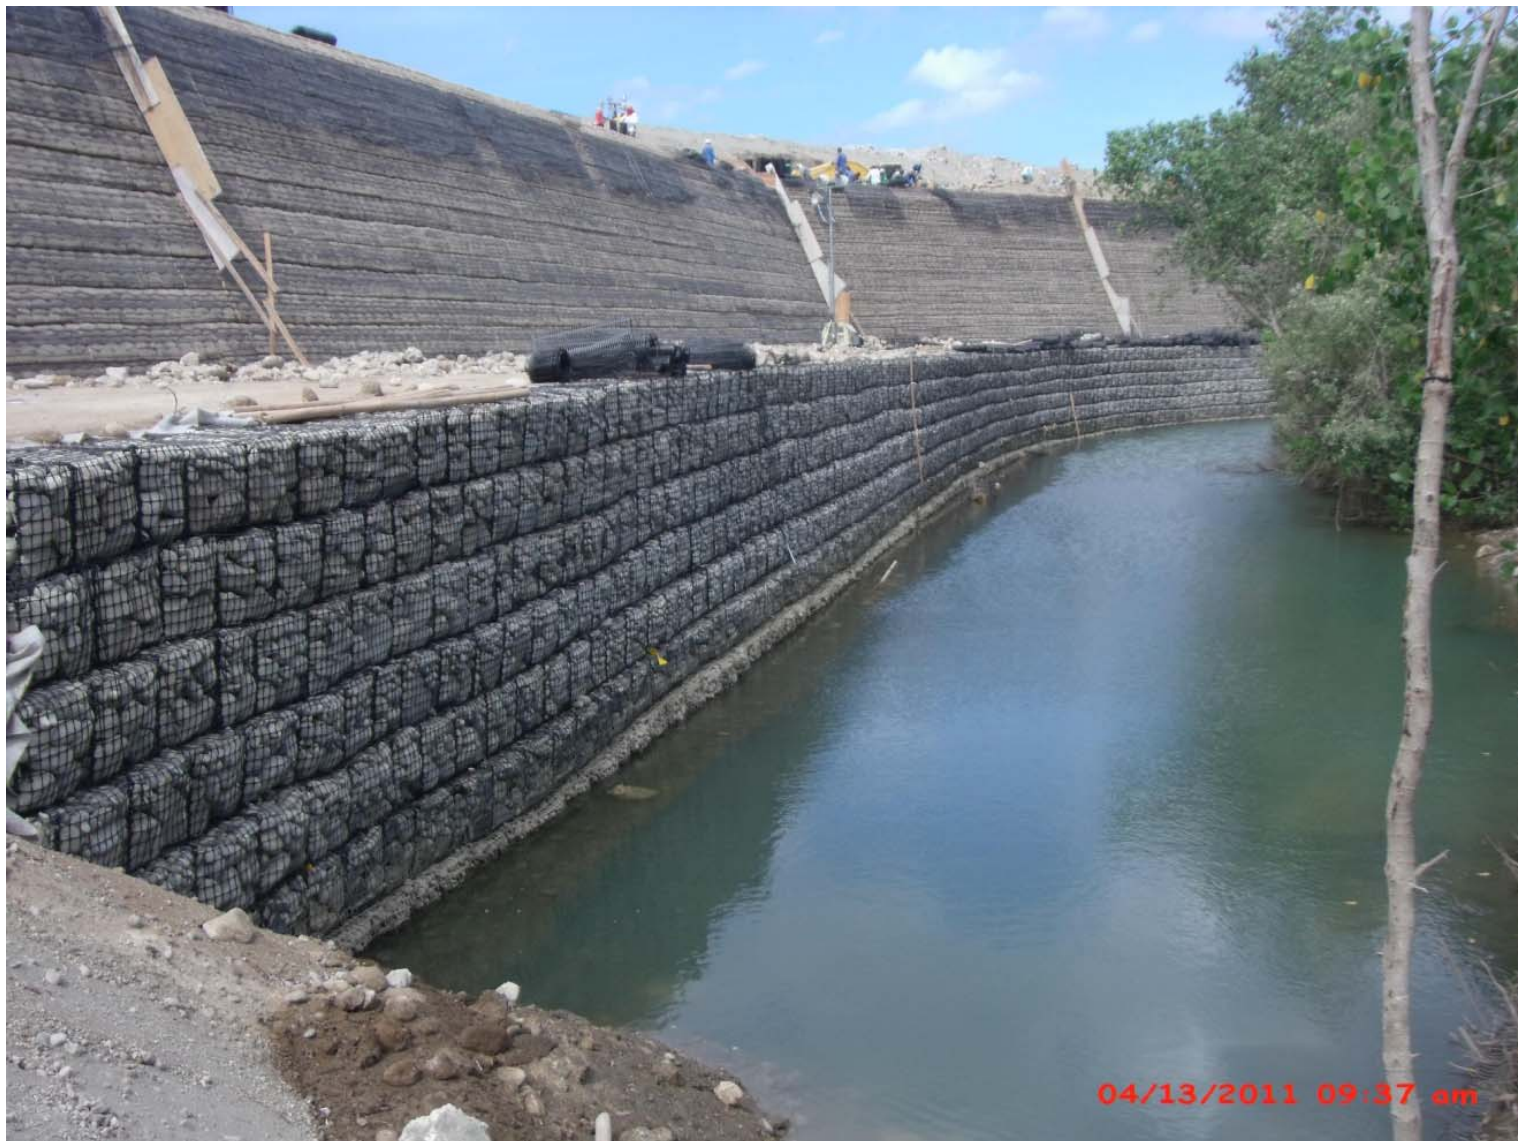
River Training and a 17 meter high Fill Embankment needed to be Reinforced with Geogrids and Gabion Toe Protection.

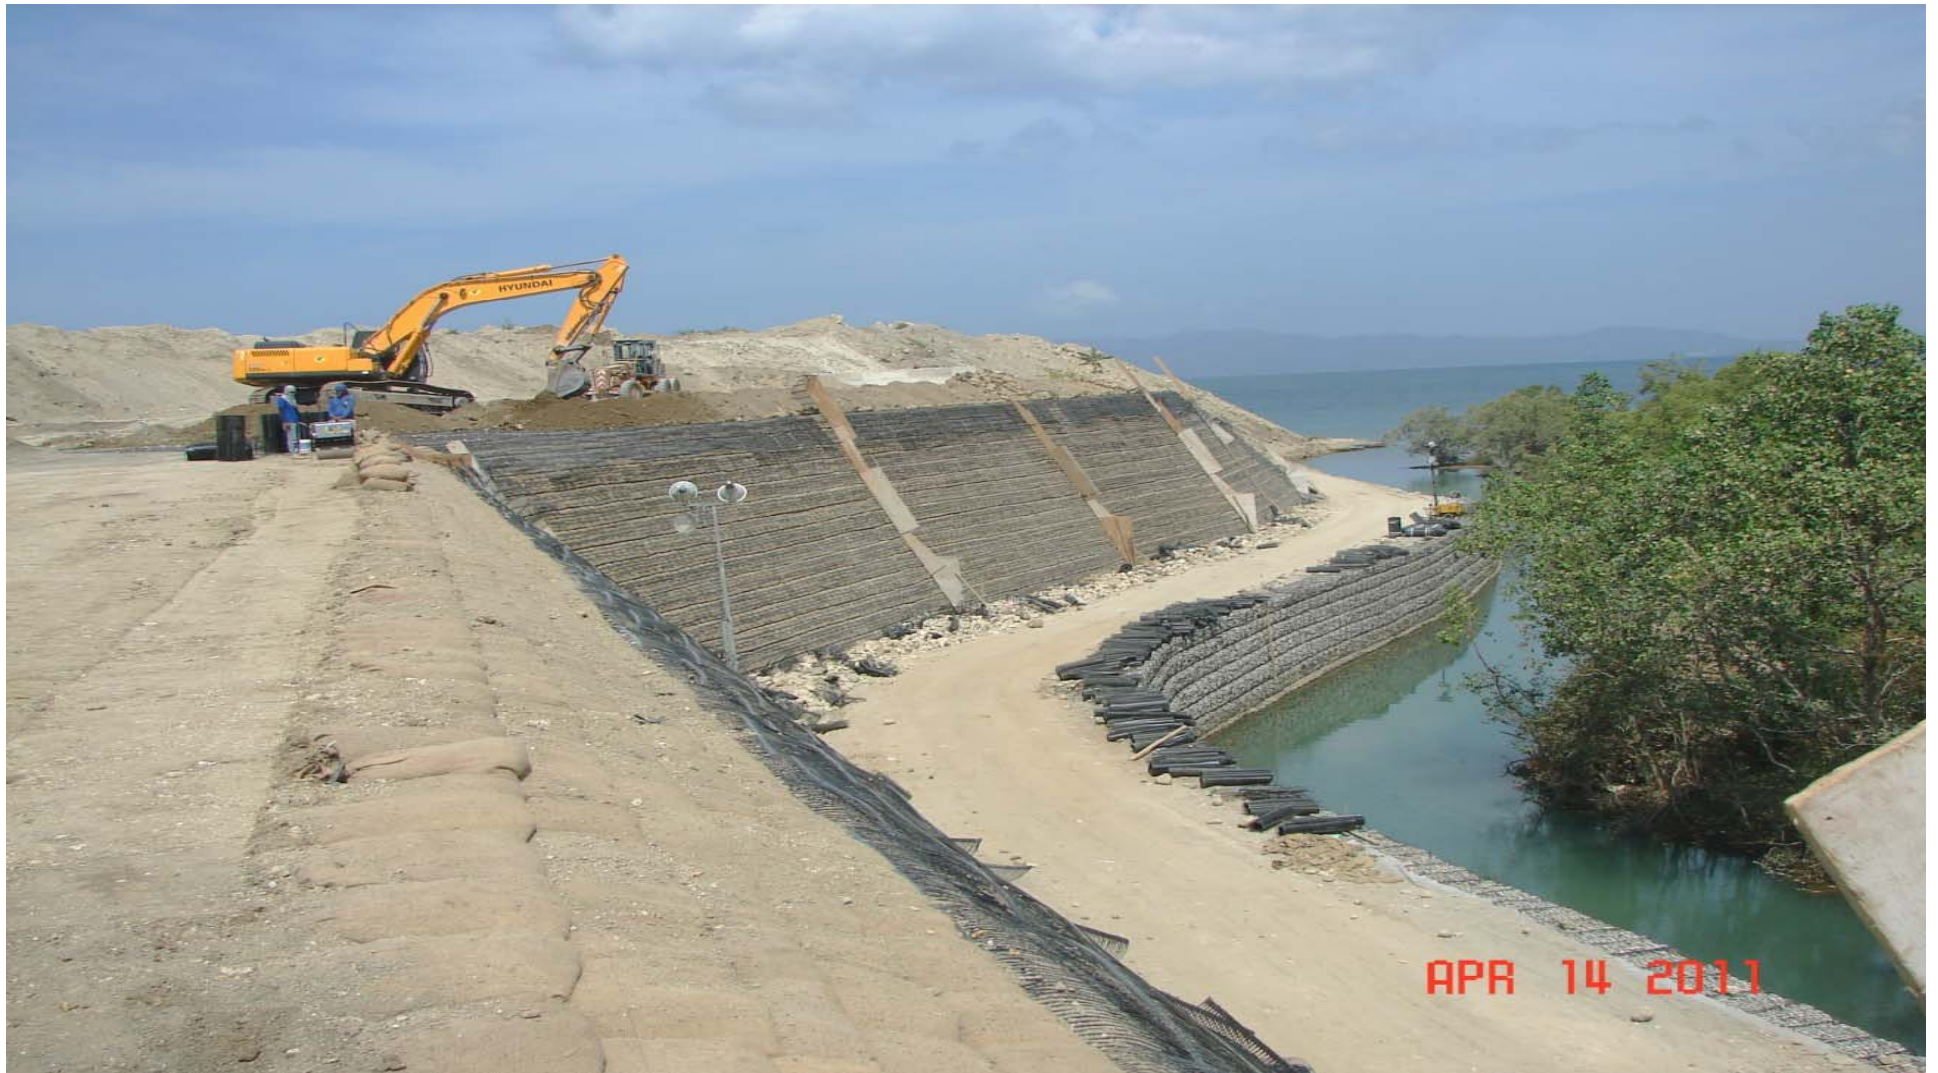
View of 16 Meter high MSE wall and River Toe Protection

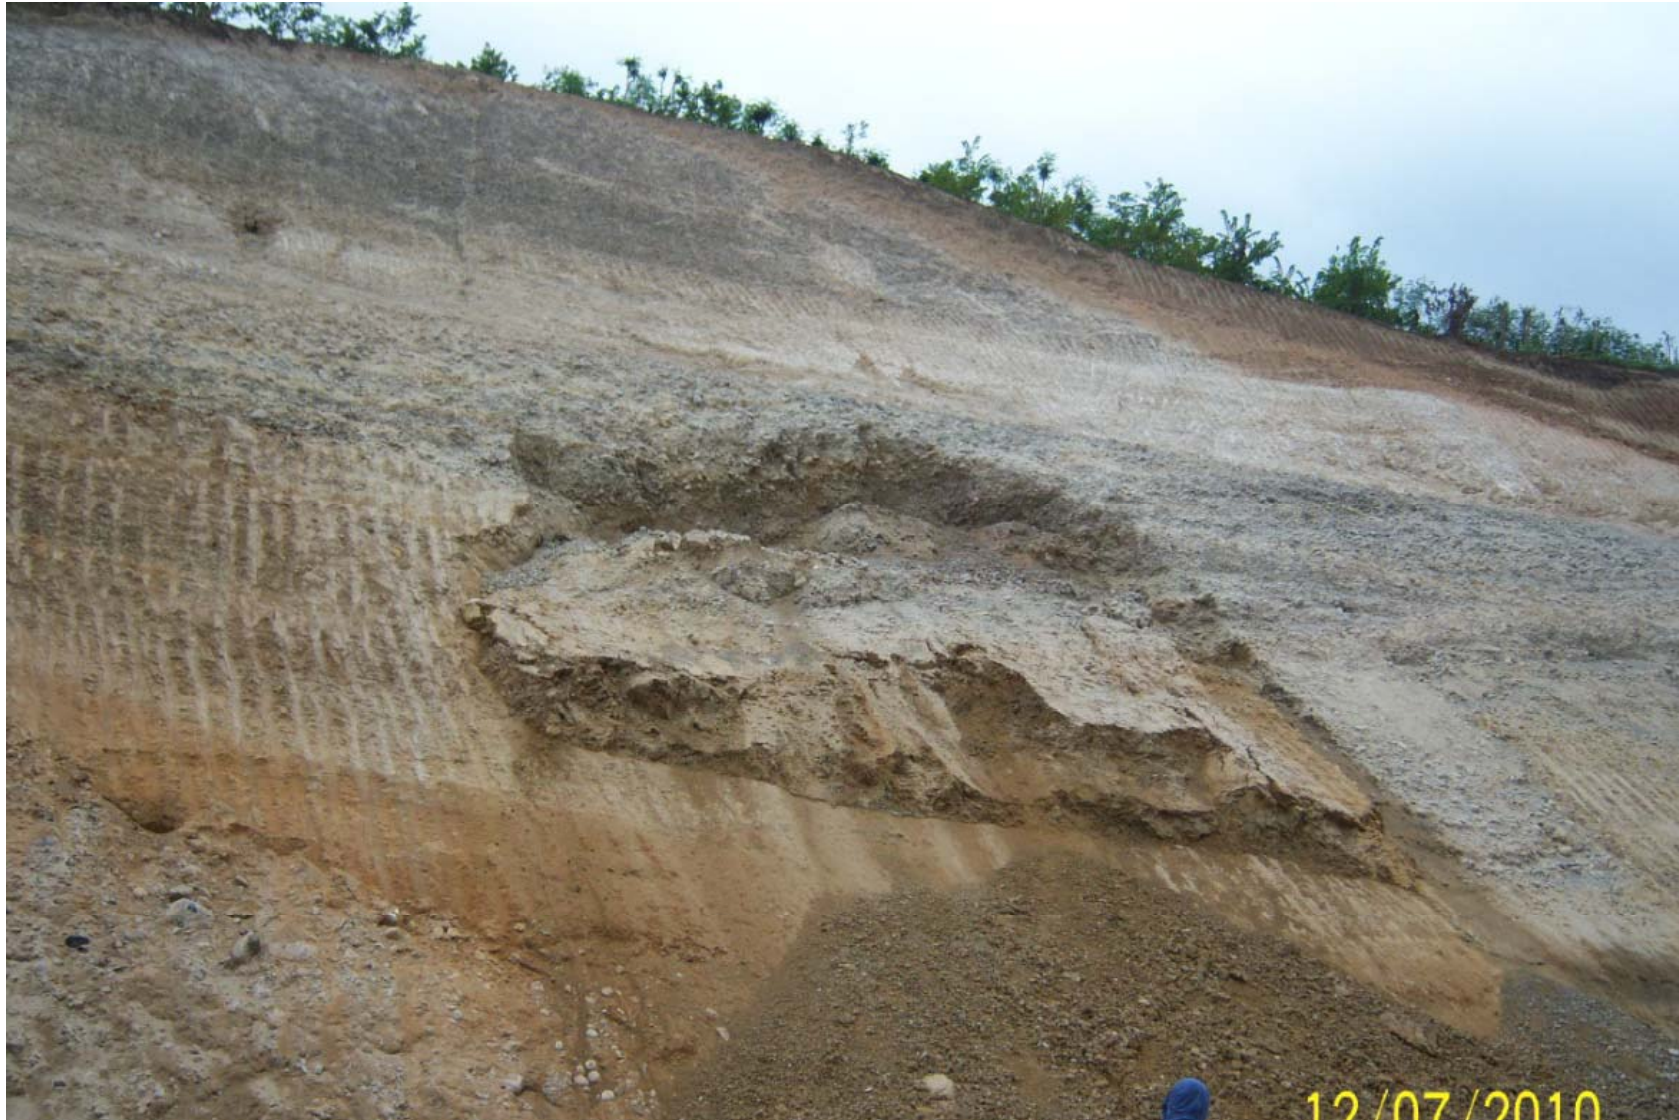
Erodible Material Undermines Competent Material

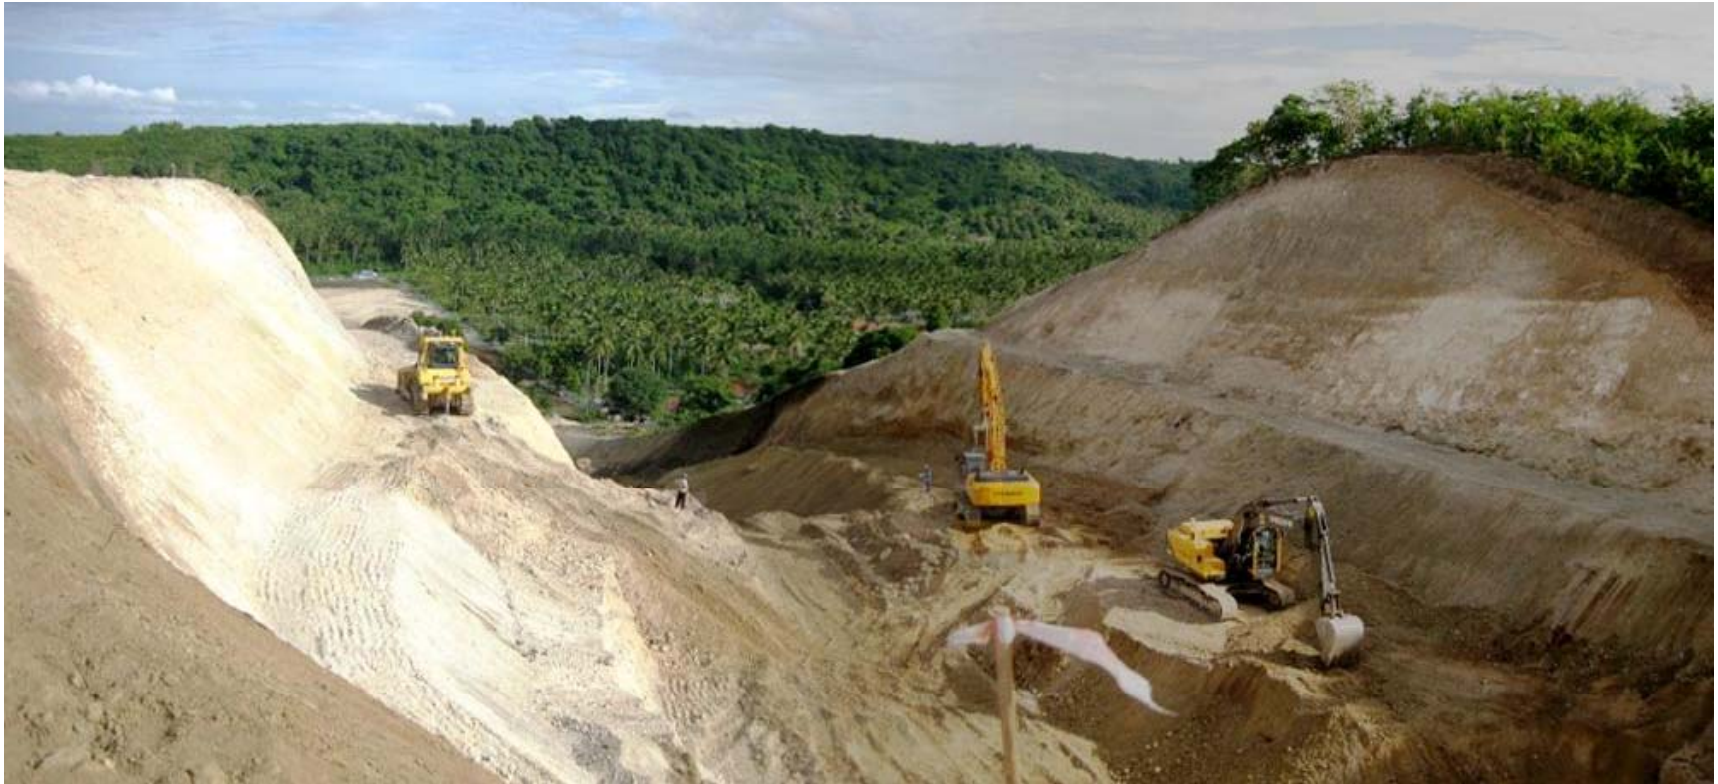
Mountain Cut Exposes Erodeable Layers

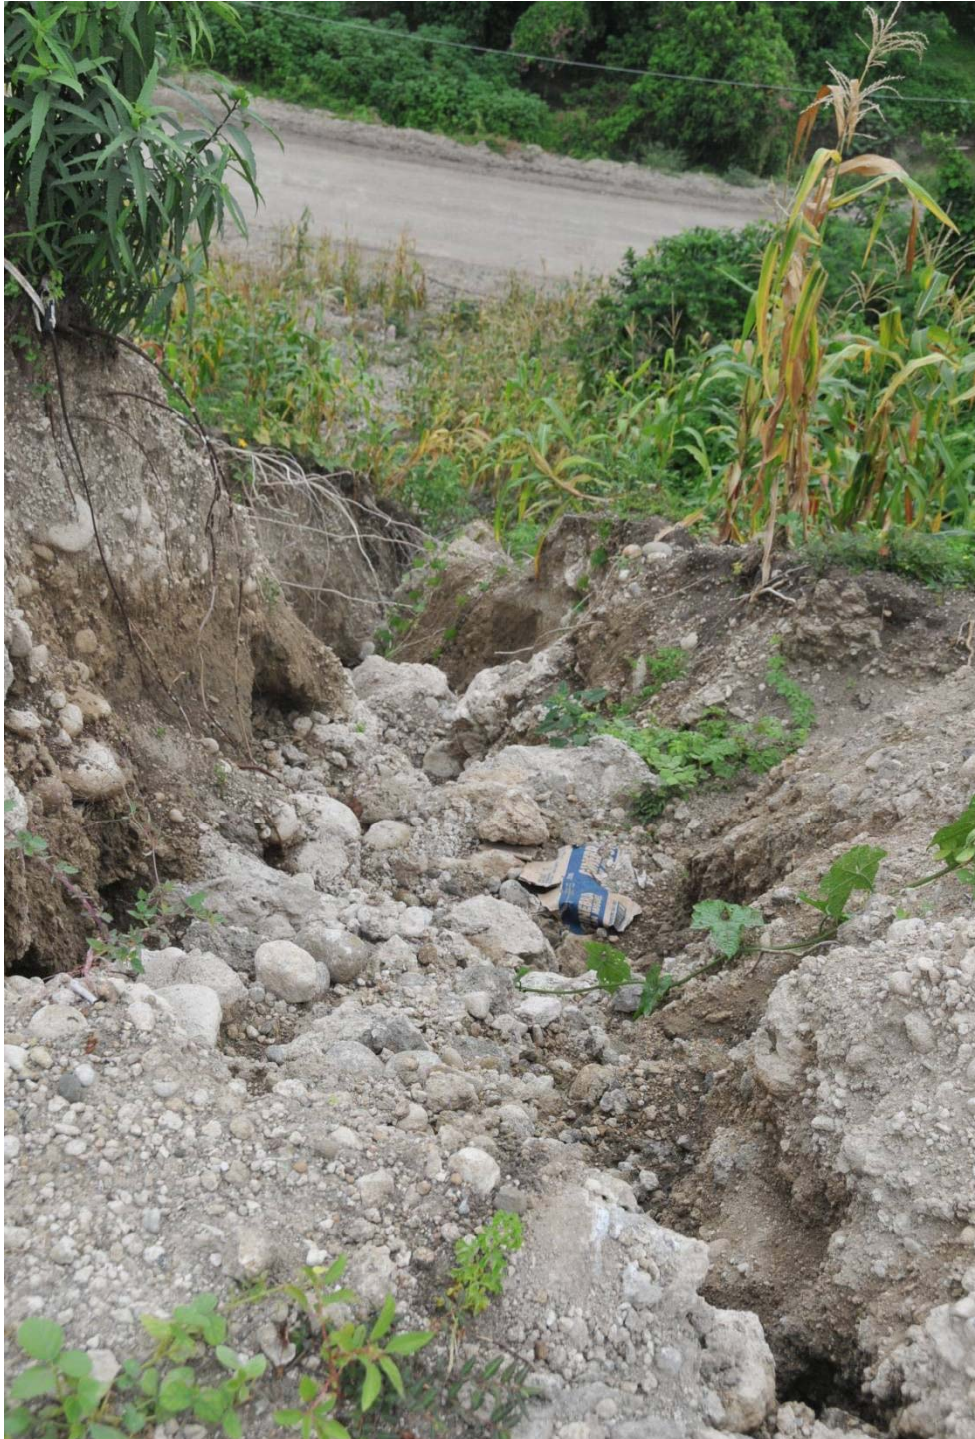
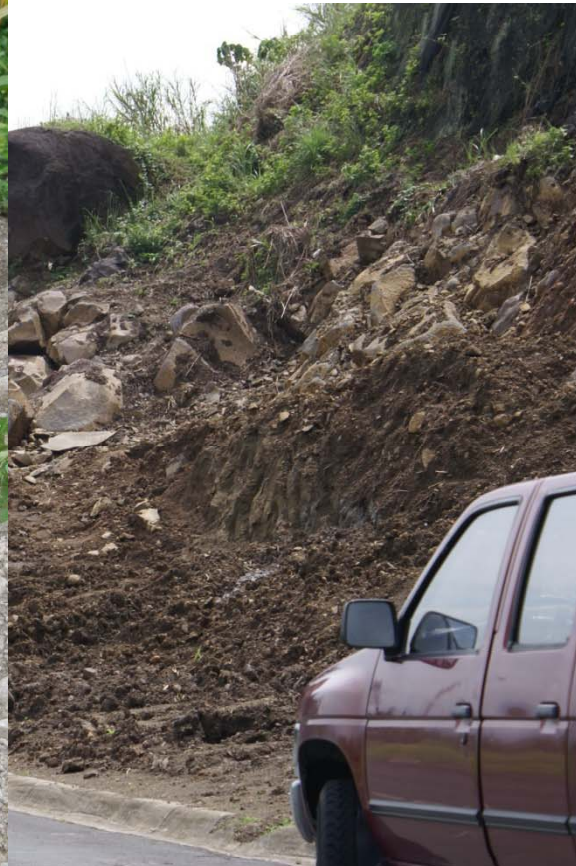
Uncontrolled Water Flow can Cause Slides and Rock Falls
