The Stability of Slopes

Emil M. Morales MSCE

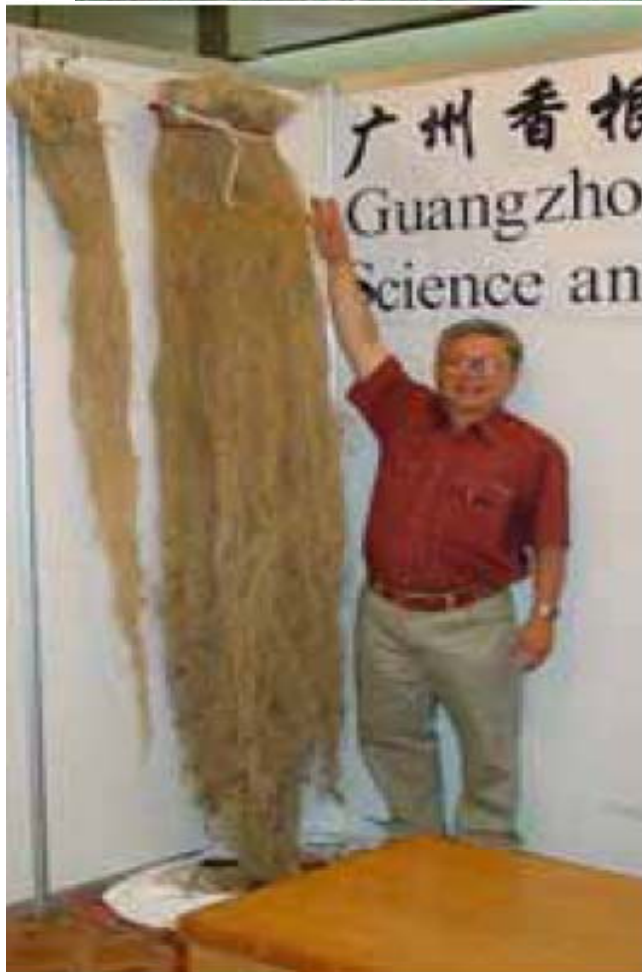
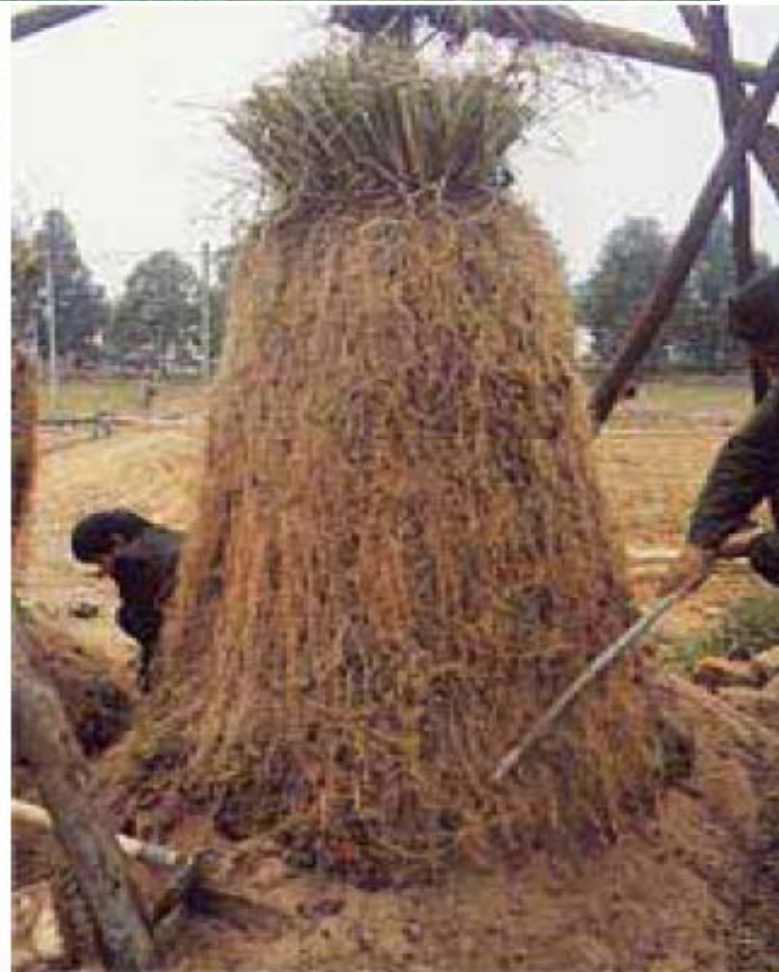
New VETIVER Plantings
