THE TRANSVERSE DIKE SPILLWAY NO. 3 FAILURE

- An Investigation into the Failure Mechanism

EMILIO M. MORALES, MSCE ¹¹

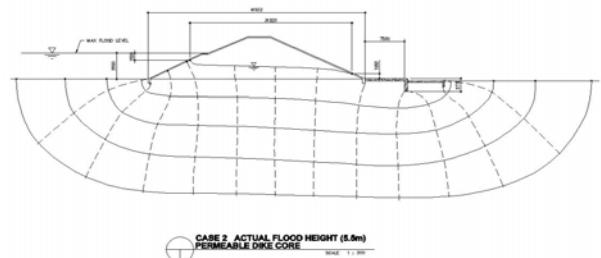
Fig 1.0 - Flownet Analysis of Transverse Dike

The figures below represent the Flownet and Finite Element computer analysis of the seepage condition at the time of failure when the floodwaters rose to 5.5 meters or about 3.5 meters from the Spillway Crest.

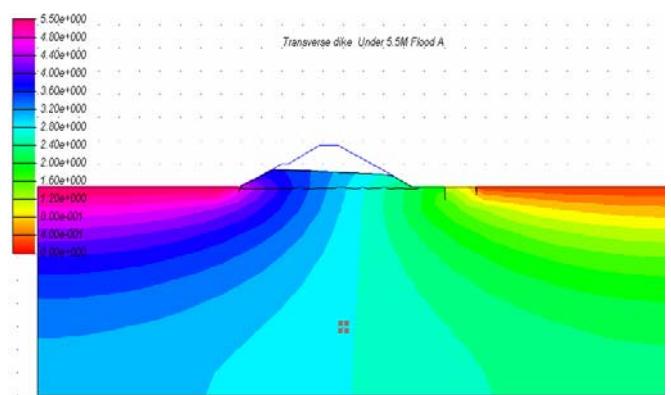
Fig 2.0 Finite Element Analysis using SEEP2D

At the flood condition of 5.5m, the resulting phreatic table elevation at the back of the downstream facing is about 2.31m as computed from the SEEP2D Finite Element Analysis.

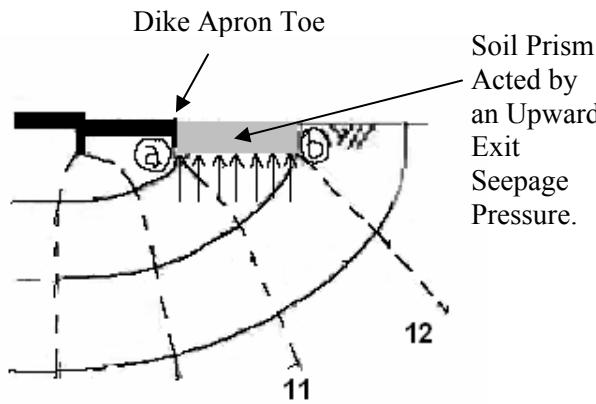
Fig 3.0 - Portion of Flownet at Downstream Exit Point

To further determine the factor of safety against piping it would be necessary to obtain the seepage forces acting upward against an element of soil at the downstream toe from the flownet of Fig. 1.0.

Between the equipotential drops $N_D=11$ and $N_D=12$, the heads are (*see Appendix "A"*).

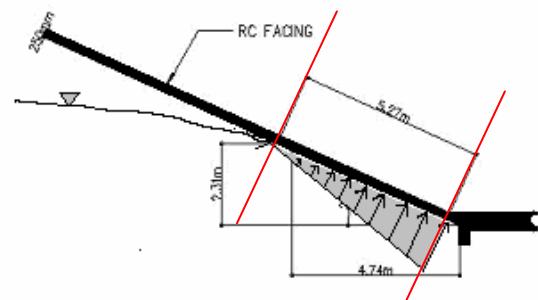
Fig 4.0 - Pressure Diagram at DS RC Facing due to Rise in Phreatic Surface in Dike Core

In order to determine the force at the back of the downstream facing, the following condition was modeled using the portion of the RC Facing subjected to Hydrostatic pressure as a 5.27 meter square plate fixed or fully restrained at all edges or a plate that is pinned on all sides:

These two support conditions represent the upper and lower extremes insofar as support condition is concerned. The assumption of a 5.27m span is a very conservative assumption since probably a shorter slab span would be more realistic. The slab was analyzed as a flat plate acted on by a triangularly varying load. The condition of fully restrained (*fixed*) and Pinned conditions were used on a 5.27m square plate dimension.

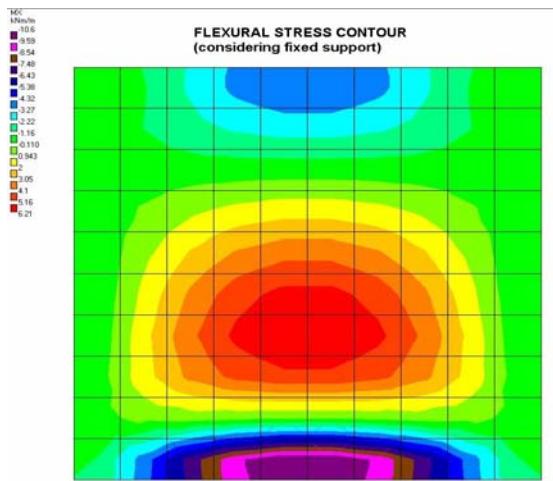
Fig 5.0 - Stress Contours of Downstream Facing Slab Subjected to Internal Water Pressure due to Rise in Phreatic Surface (Fixed Ends)

$M_{Capacity}$	=	11.42 kN-m
M_{Fixed}	=	6.21 kN-m (Very Safe)
M_{Pinned}	=	13.80 kN-m (20% over)

Thus, it can be seen that even at the Pinned condition, the facing is only 20% overstressed and is very safe using a full Fixed condition.

The truly realistic condition would be somewhere in between these two support conditions that would render the facing safe for the flood condition, not to mention the very conservative large slab span assumed.

From the foregoing, we can conclude that the R.C. facing did not fail from the hydrostatic pressure developed inside the Dike Core.

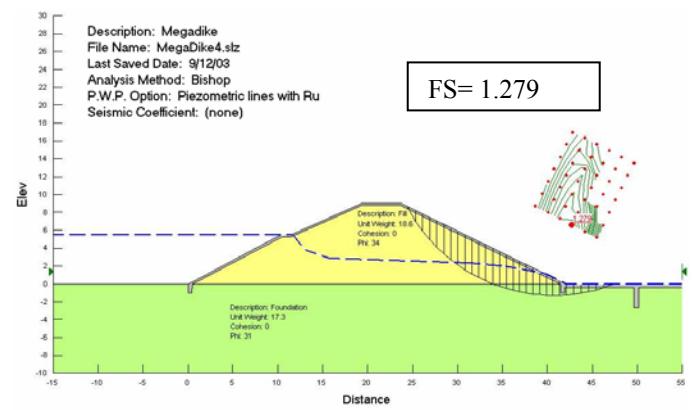
Fig 6.0 - Result of Slope Stability Analysis using SLOPE/W at Static Condition

The slope stability analysis results indicated that the Dike is safe at static condition with a Factor of Safety (FS) equal to **1.279**.

Earthquake loading was considered in the analysis corresponding to a 5.8 Magnitude Earthquake coincident with the flood level of 5.5M Flood as a purely academic exercise. The results show that the dike is marginally safe (**FS=0.989**) for combined earthquake and flood level of 5.5 meters, which is an unlikely combination.

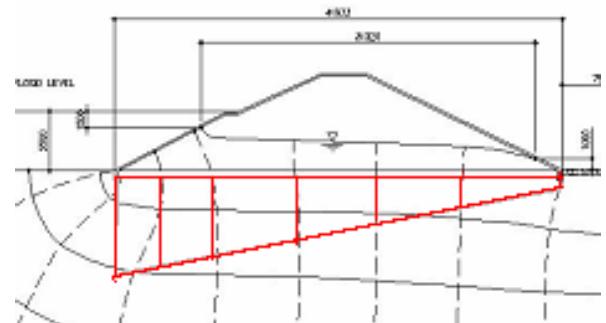
Fig 7.0 - Pore Pressure Distribution at Base of Dike due to 5.5m Flood Height

From the Flownet analysis, the equipotential lines intersecting the base of the dike are converted to upward pressure. This pressure tends to heave the dike and is only counteracted by the weight of the Dike Structure.

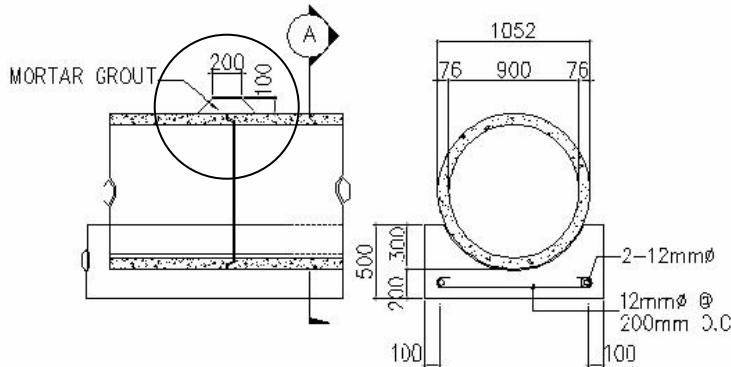
Fig 8.0 Detail of Pipe RC Bedding as per Plan

The R.C. Pipes are 900 mm Ø x 1.0 meter long. These were designed to be bedded or laid on a Reinforced Concrete Bedding in turn resting on a well compacted subgrade composed of dike core materials shown in the revised project plans and sketched here below as Fig. 8.0.

The detail above shows that the bedding concrete is to be reinforced by 2-16 mm Ø Longitudinal rebars and 12 mm Ø transverse ties at 200 mm on centers.
